ELK CONSERVATION DISTRICT  
BIO ENGINEERING PROJECT

HAMRIC FARM  
VERNON AND DEBBIE HAMRIC  
TATE CREEK -- BRAXTON COUNTY

Bruce Skidmore Conservation Specialist WVCA

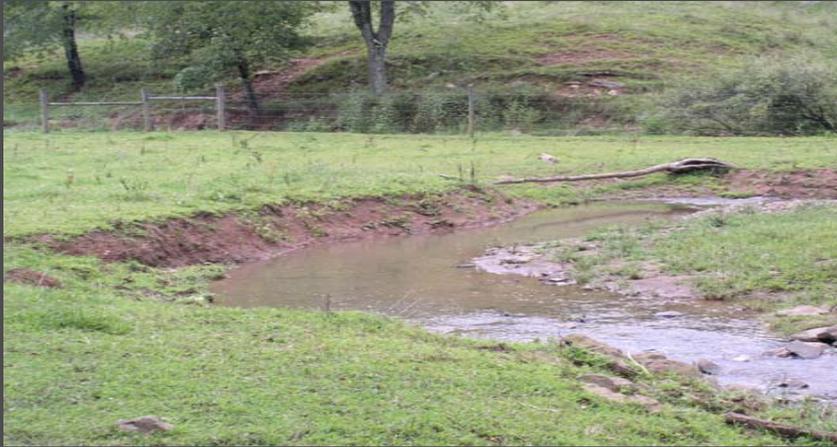
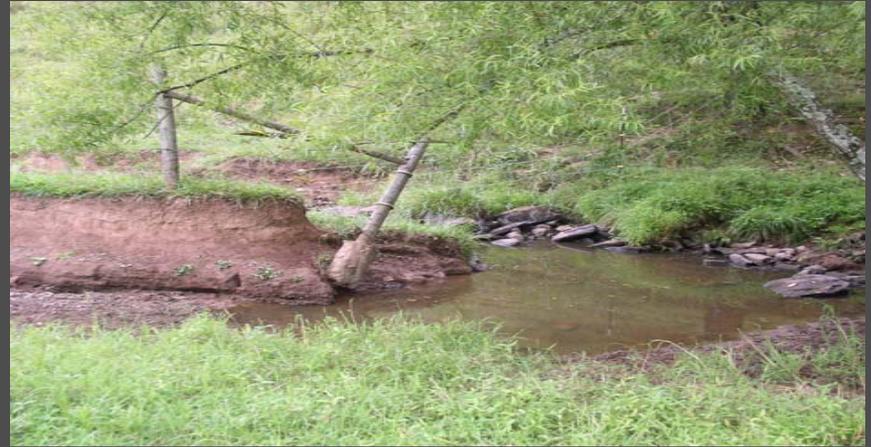
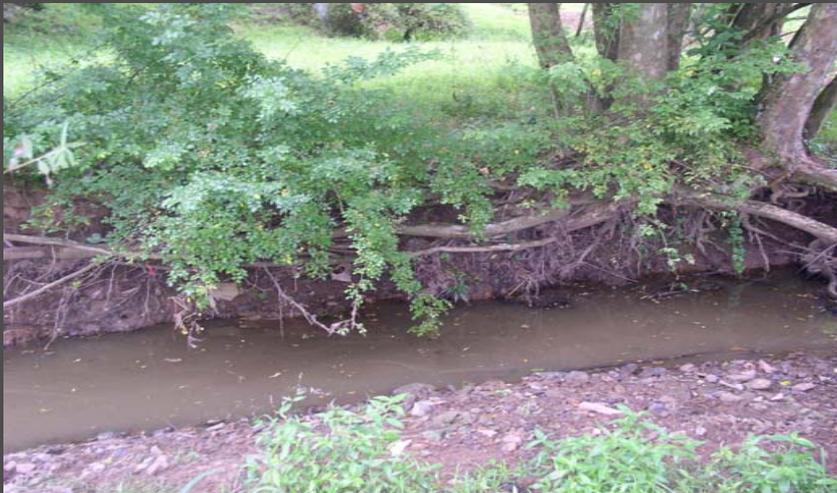
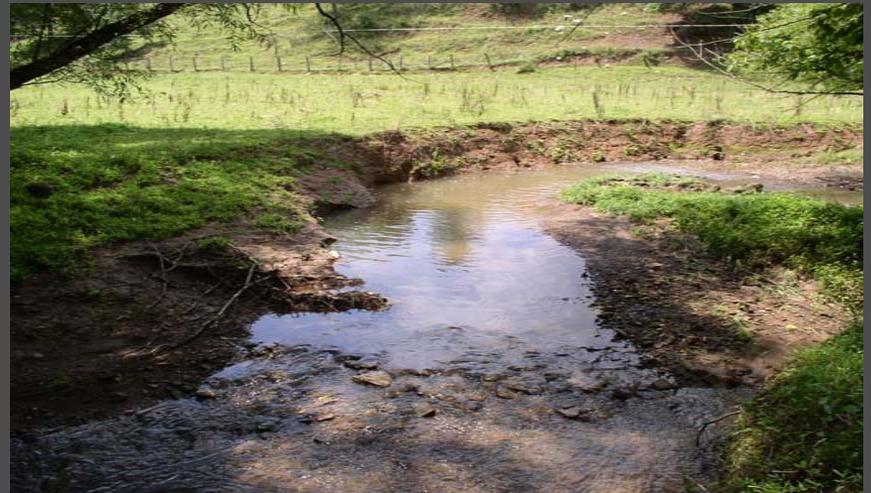
# Stream bank erosion on Tate Creek before the project

Mr. Hamric was loosing approximately 50 ton/ac/year of soil from his pasture
