# REHABILITATION ASSESSMENT REPORT

## Brush Creek Watershed Site 9

Mercer County, West Virginia

**March 2011**

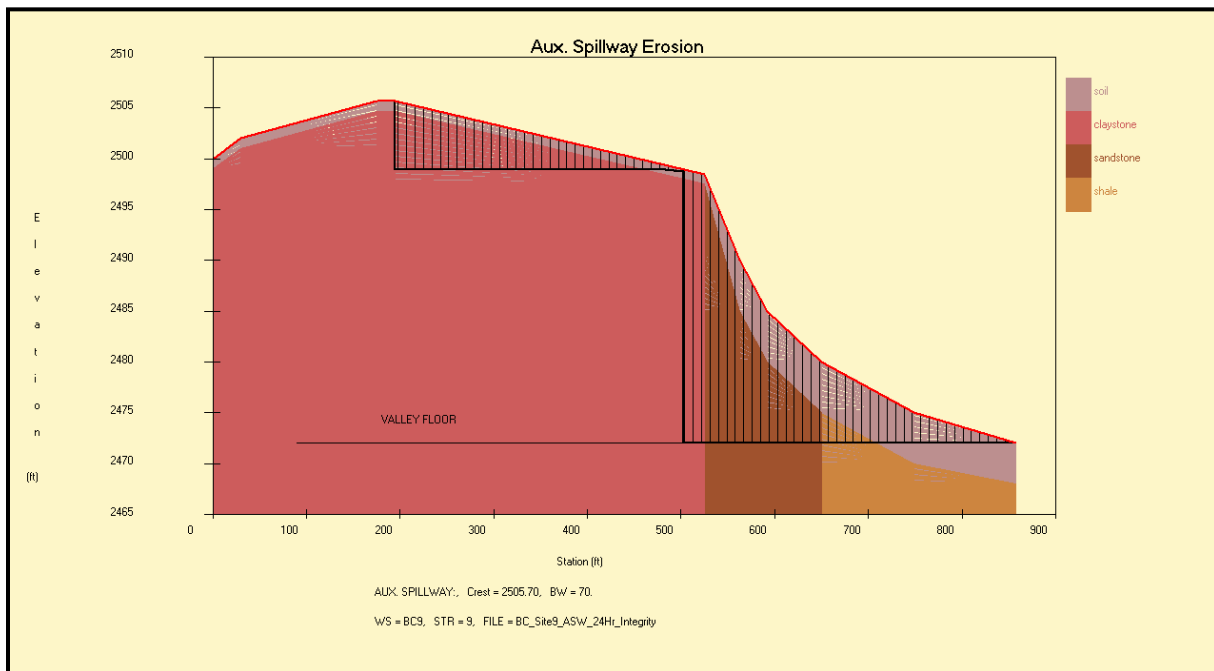
Figure 3. Plot of Auxiliary Spillway Profile and Extent of Erosion from Integrity Analysis for 24-hour Class C Freeboard Hydrograph (PMF) Obtained from SITES Model Output

The SITES auxiliary spillway analysis shows that the auxiliary spillway crest experiences significant damage, including a shallow headcut that extends up to the control section of the spillway, during passage of the 24-hour FBH. A similar extent of damage will occur during the 6-hour duration event.

Assuming the dam must satisfy Class C (*high hazard*) design criteria, the only identified deficiency is the early activation of the auxiliary spillway. The preliminary SITES integrity analysis determined that the auxiliary spillway would experience a significant but acceptable amount of damage during passage of the Freeboard Hydrograph. Therefore, armoring of the spillway will not be required.

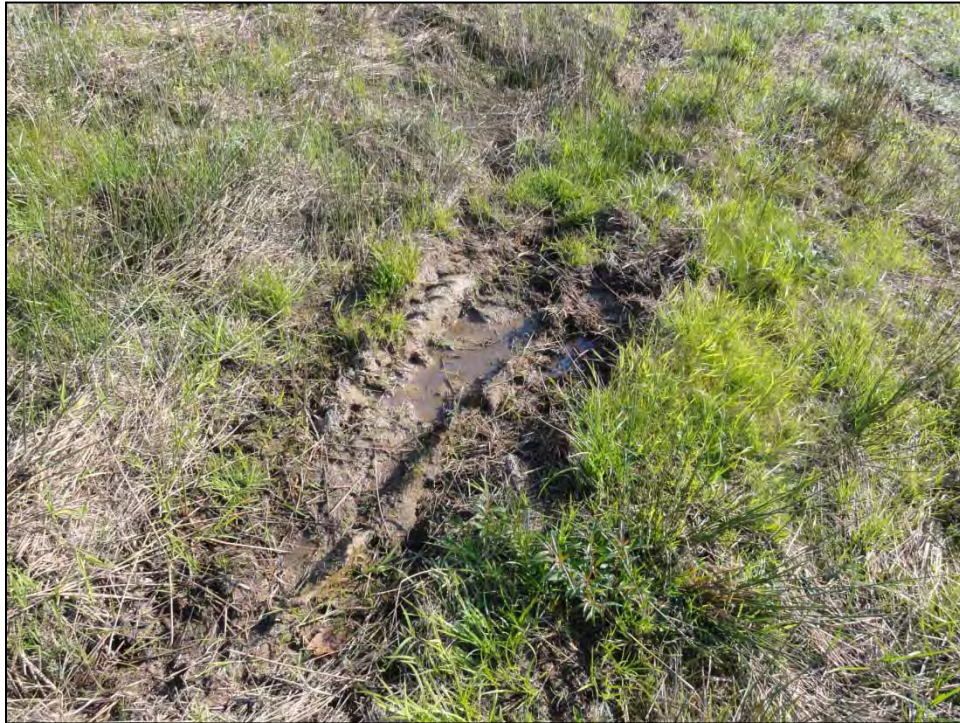
The CMP drains located on either side of the principal spillway outlet conduit were both flowing at greater than ½ gpm. Wet areas were observed below the toe of the dam on both the left and right sides of the stilling basin, possibly due to poor drainage. Otherwise, no signs of embankment instability or seepage were observed.

7. Wet areas on both left and right side of stilling basin.

Items of deferred maintenance include repairing and armoring areas damaged by wave erosion, seeding bare areas, painting corroded metal on the riser structure, repairing the ladder, removal of obstructions within the auxiliary spillway, and clearing sediment and vegetation from the outlet channel. Wet areas on both sides of the stilling basin should also be monitored.

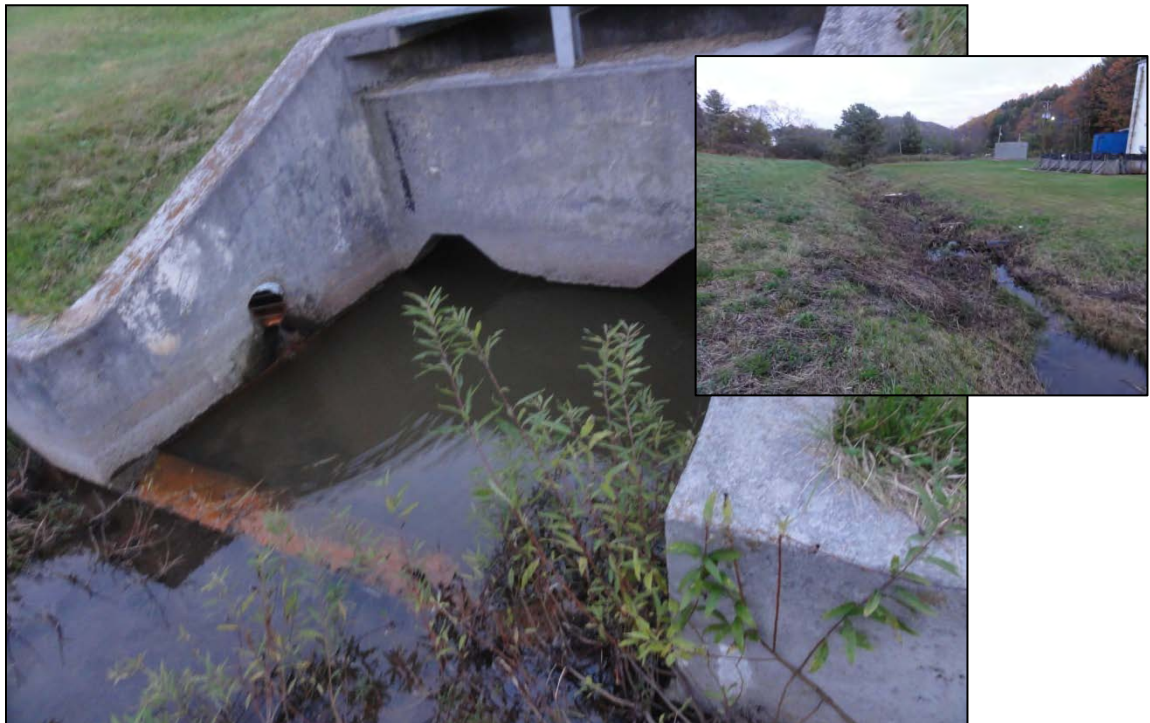
The concrete principal spillway riser structure and stilling basin appear to be in good condition and operating as designed. No external evidence of cracking or deterioration was observed. Metal parts on the lower portion of the riser are showing signs of corrosion and need to be painted. The bottom rungs of the ladder are missing. Sediment and vegetation are clogging the outlet channel downstream of the stilling basin causing a backwater that extends over the endsill and nearly submerges the conduit.

8. Backwater from outlet channel submerging the endsill and conduit outlet invert.

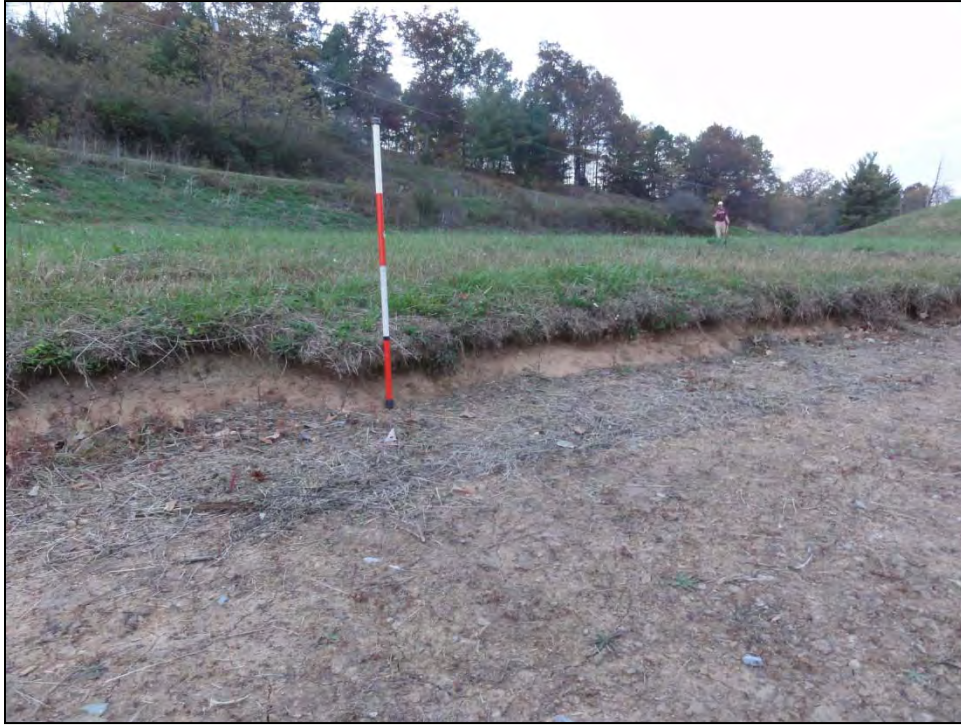
There is significant wave erosion on the entrance slope of the auxiliary spillway. A bare, unvegetated area was observed on the outslope of the spillway. There are also a few minor obstructions (trash cans, fence posts, etc.) within the auxiliary spillway channel.

Photos 9 and 14 in Appendix B show features observed during the site visit including wave erosion of the entrance slope of the spillway and an unvegetated area in the spillway that can also accelerate erosion of the spillway. These features have not been incorporated in the SITES auxiliary spillway analysis but should be considered in evaluating the overall integrity of the spillway. The SITES output for both the 6-hour and 24-hour storms for as-built, Class C criteria are presented in Appendix C. The electronic input files for the SITES model are furnished in the Supporting Data Folder on a CD.

9. Erosion of entrance slope of the auxiliary spillway.

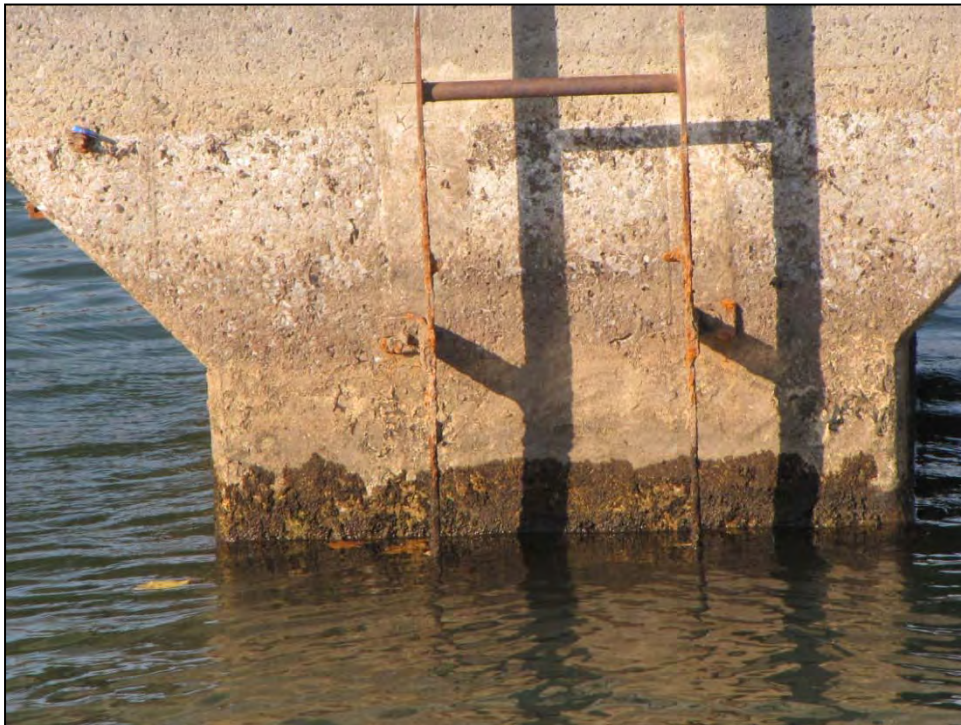
i. Ladder intact?		X		Missing bottom rungs.
j. Pedestal securely fastened?				Not accessed. Unknown.
k. Floodgates operational?				Not accessed. Unknown.

10. Bottom rungs missing on riser structure ladder.

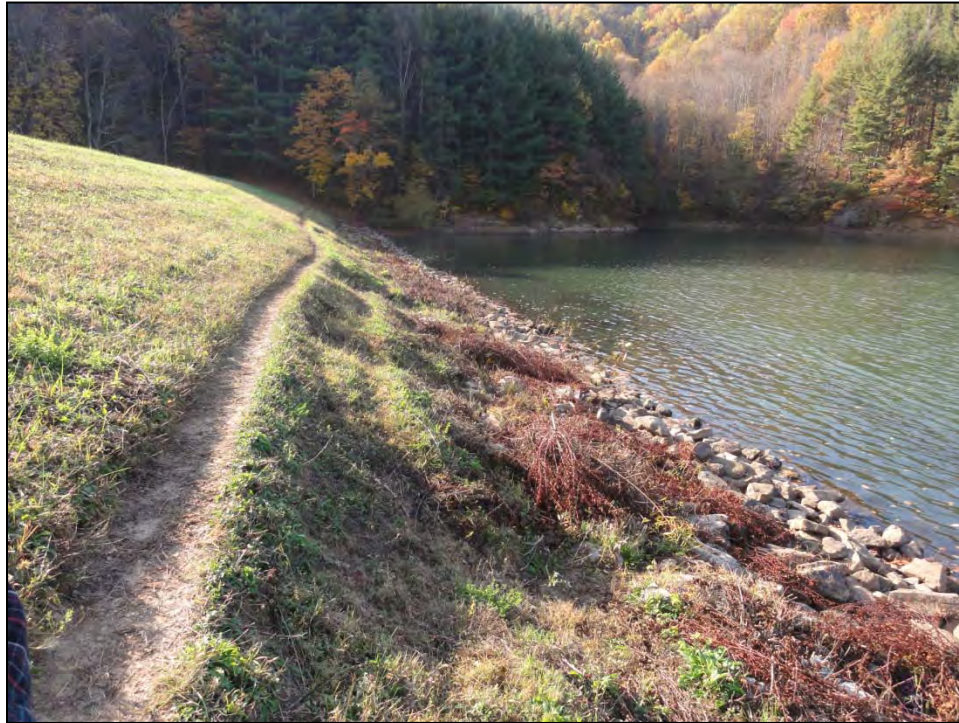
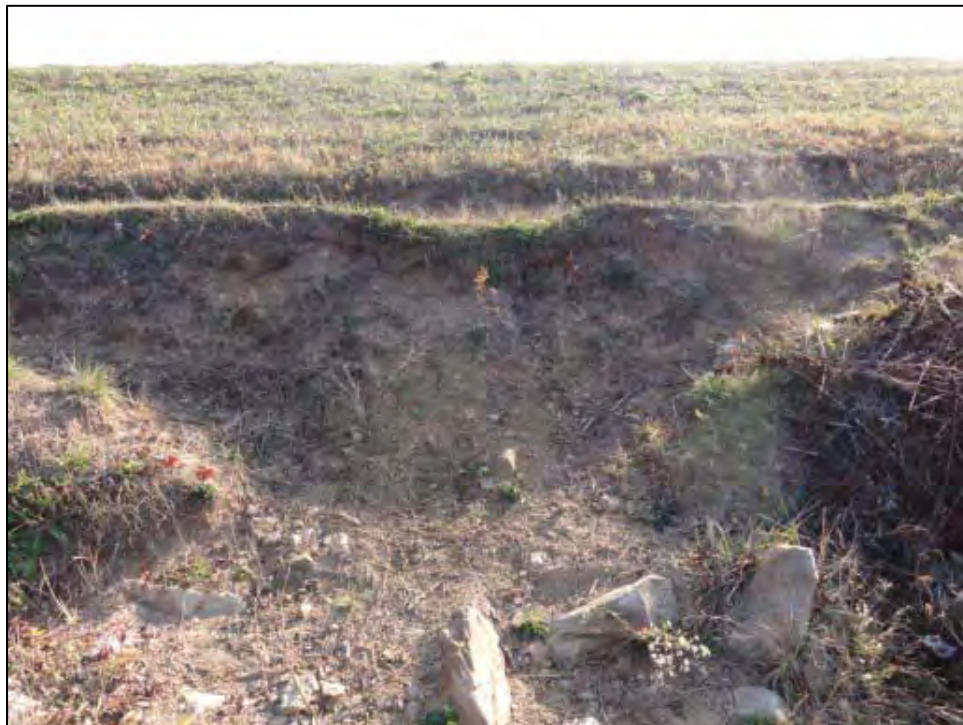
There are bare earth trails and areas of significant wave erosion and sloughing on the upstream slope of the embankment. The grass cover on the downstream slope of the dam embankment appears to be adequate.

11. Bare earth trail, wave erosion, and sloughs near pool level on upstream slope.

12. Bare earth trail, wave erosion, and sloughs near pool level on upstream slope.

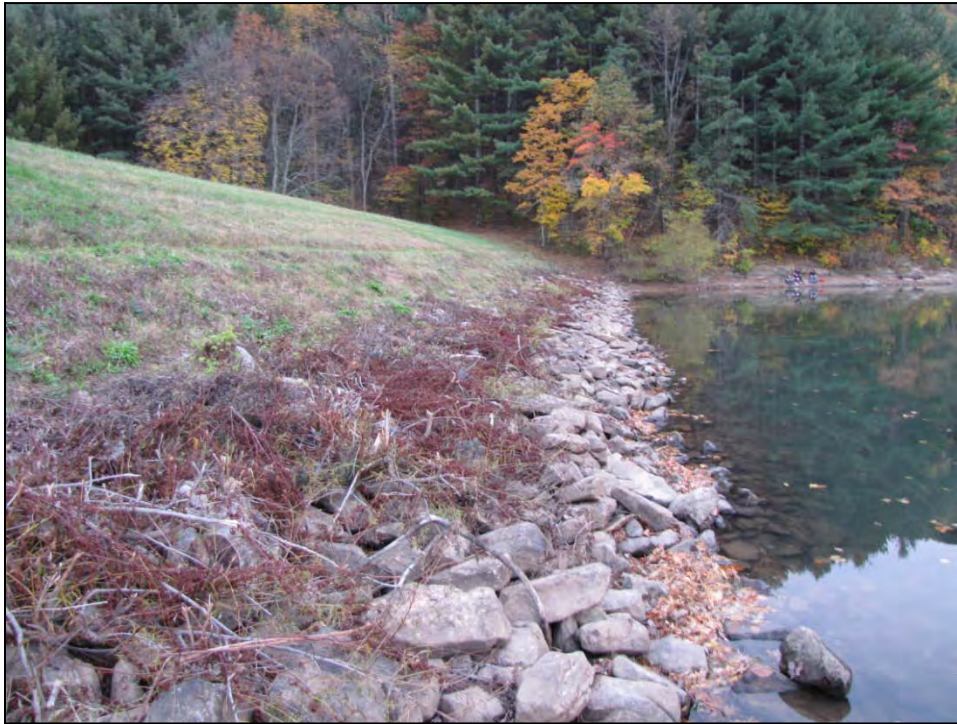
13. Woody vegetation growing within riprap on upstream slope was recently cut; stumps of woody vegetation remain.

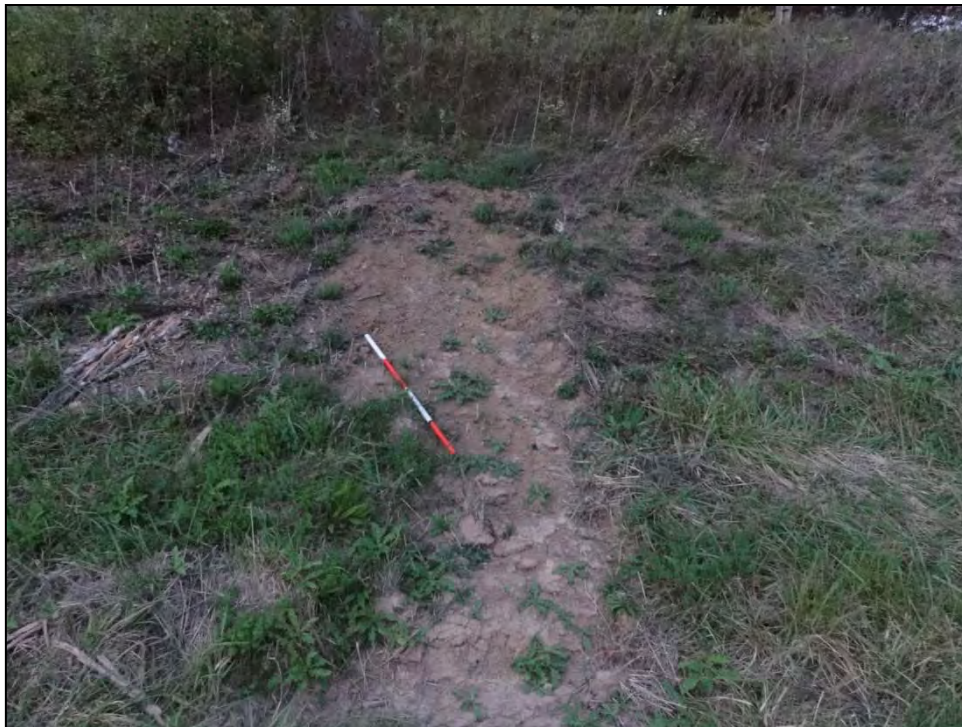
14. Unvegetated area on outslope of auxiliary spillway.

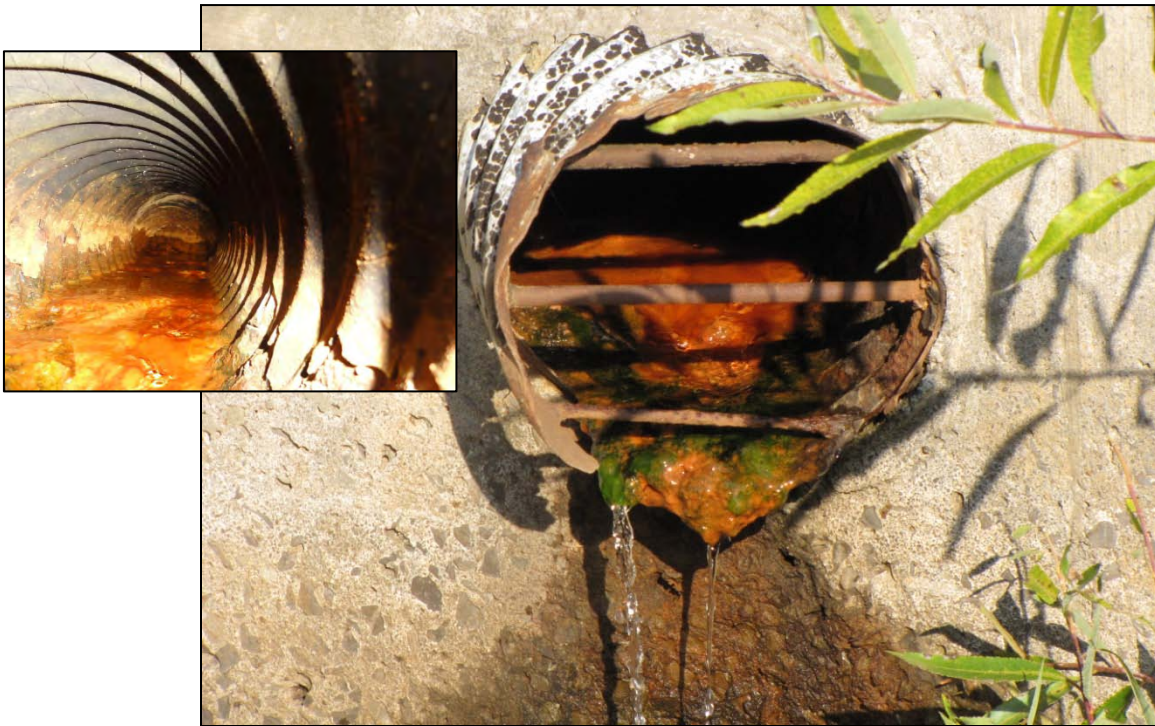
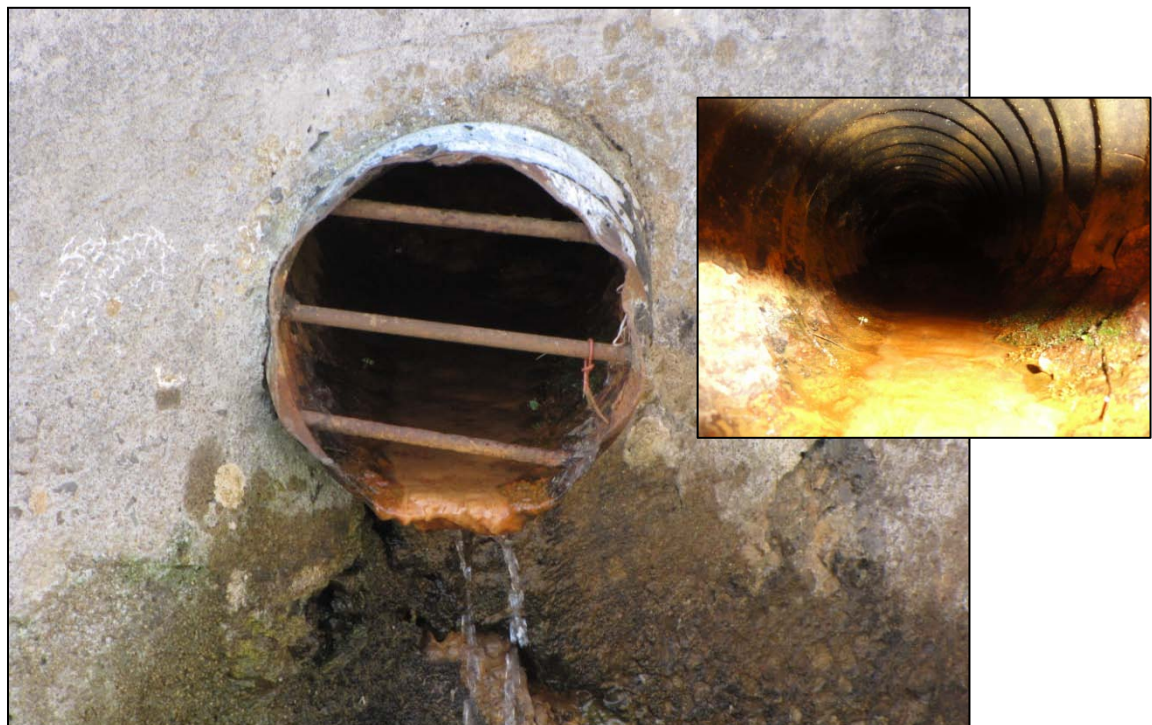
15. Left CMP drain.

16. Right CMP drain.
