# REHABILITATION ASSESSMENT REPORT

## New Creek Watershed Site 17

Mineral County, West Virginia

**March 2011**

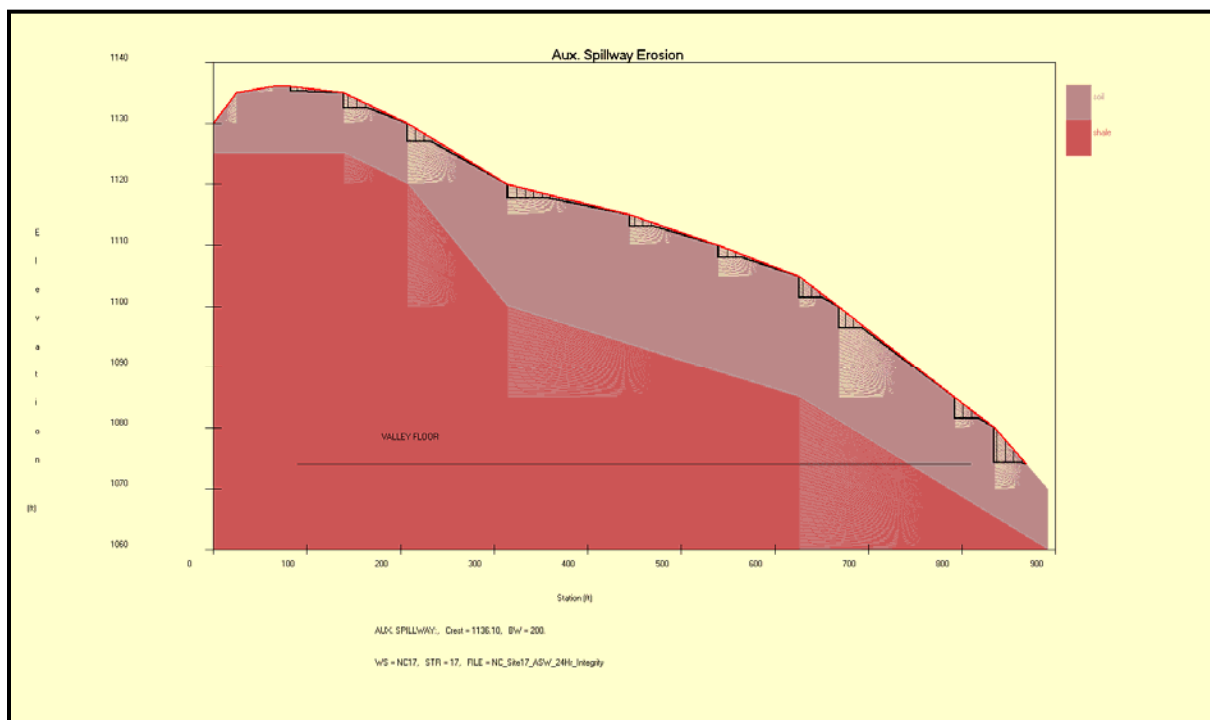
Figure 3. Plot of Auxiliary Spillway Profile and Extent of Erosion from Integrity Analysis for 24-hour Class C Freeboard Hydrograph (PMF) Obtained from SITES Model Output

The SITES auxiliary spillway analysis shows only minor damage for both the 6-hour and 24-hour duration storm events. Photos 9 and 16 show features including trees and a small, wooden fence observed in the auxiliary spillway during the site visit that can accelerate erosion of the spillway. These features have not been incorporated in the SITES auxiliary spillway

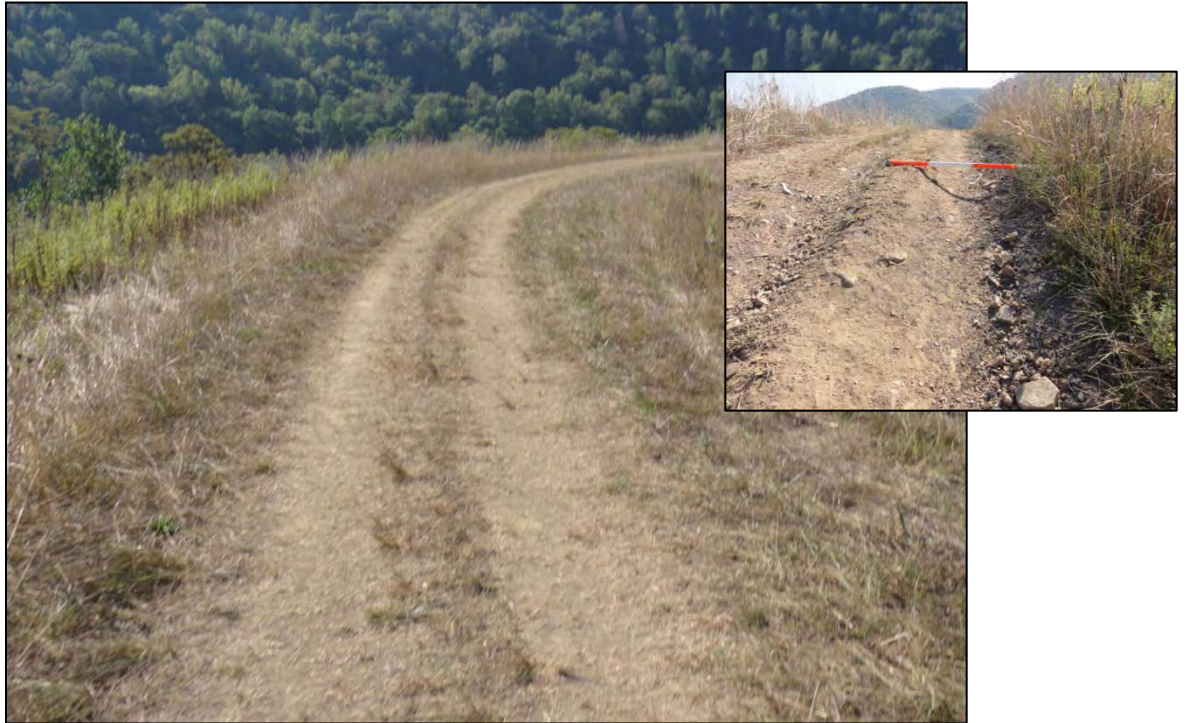
Bare earth tire ruts were observed on the crest of the dam as well as on the auxiliary spillway training dike and the left side of the downstream slope. An animal burrow was observed near the toe of the downstream embankment. A small, wooden fence runs through the channel of the auxiliary spillway.

c. Settlements, misalignments or cracks?	X			Downstream slope
d. Vehicle ruts or animal trails?	X			Bare earth tire ruts along crest of dam, down auxiliary spillway training dike, and on left, downstream face

7. Bare earth tire ruts on dam crest, left side of upstream slope, and auxiliary spillway training dike.

Items of deferred maintenance include removal of woody vegetation from the embankment and auxiliary spillway, filling groundhog holes, filling and seeding bare earth tire ruts, removal of small fence in the auxiliary spillway, repairing the concrete lining of the principal spillway outlet conduit, clearing vegetation and trees away from the plunge pool area, painting the lower trash rack and drawdown handwheel, and clearing debris from the riser structure. Gates should also be replaced in order to reduce motorized traffic across the dam crest. In addition to these maintenance items, the seep below the principal spillway should be monitored. Also, long-term maintenance issues as well as possible stability concerns for the downstream slope of the embankment should be investigated and addressed.

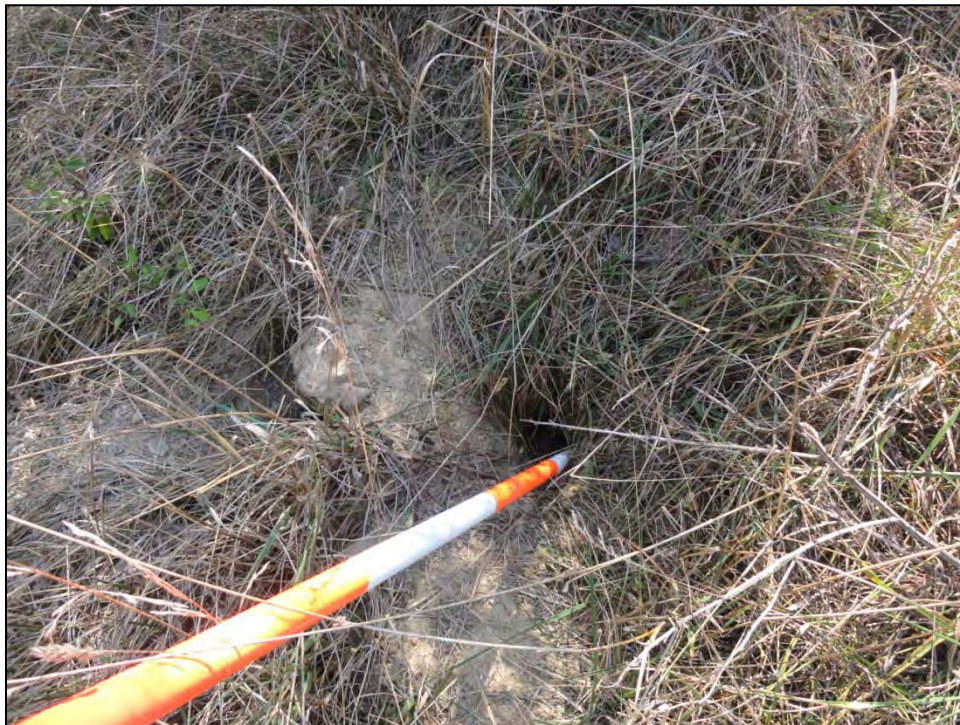
8. Animal burrow near toe of downstream embankment.

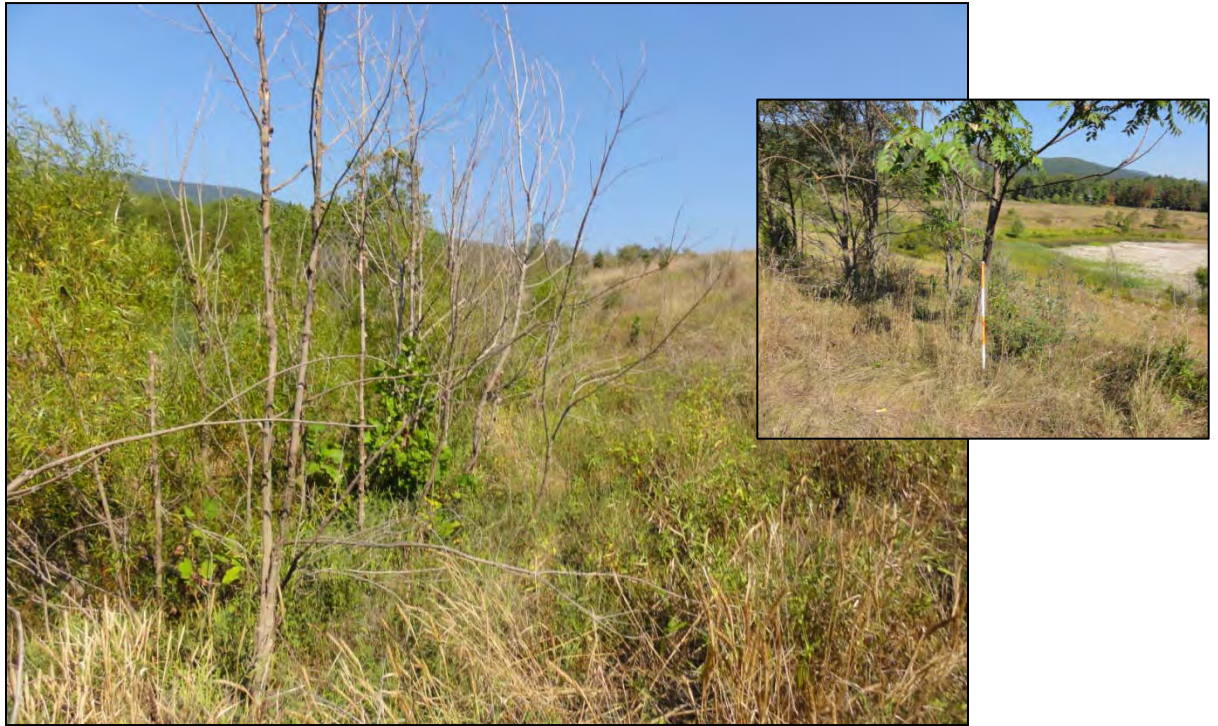
The grass cover on the upstream and downstream slope of the dam embankment has not been mowed for several years as evidenced by brush and small trees on both the upstream and downstream slopes. The downstream slope was constructed with a steep 2:1 slope and armored in some areas with large cobbles. Due to the inability to mow the areas covered in cobbles, vegetation has become very dense in these areas. Additionally, the slope in these areas seems very irregular which suggests there has been some creep of the downstream slope. Large trees were also observed to be encroaching on the abutment contacts of the dam.

9. Woody vegetation on upstream slope of dam embankment and auxiliary spillway entrance slope.

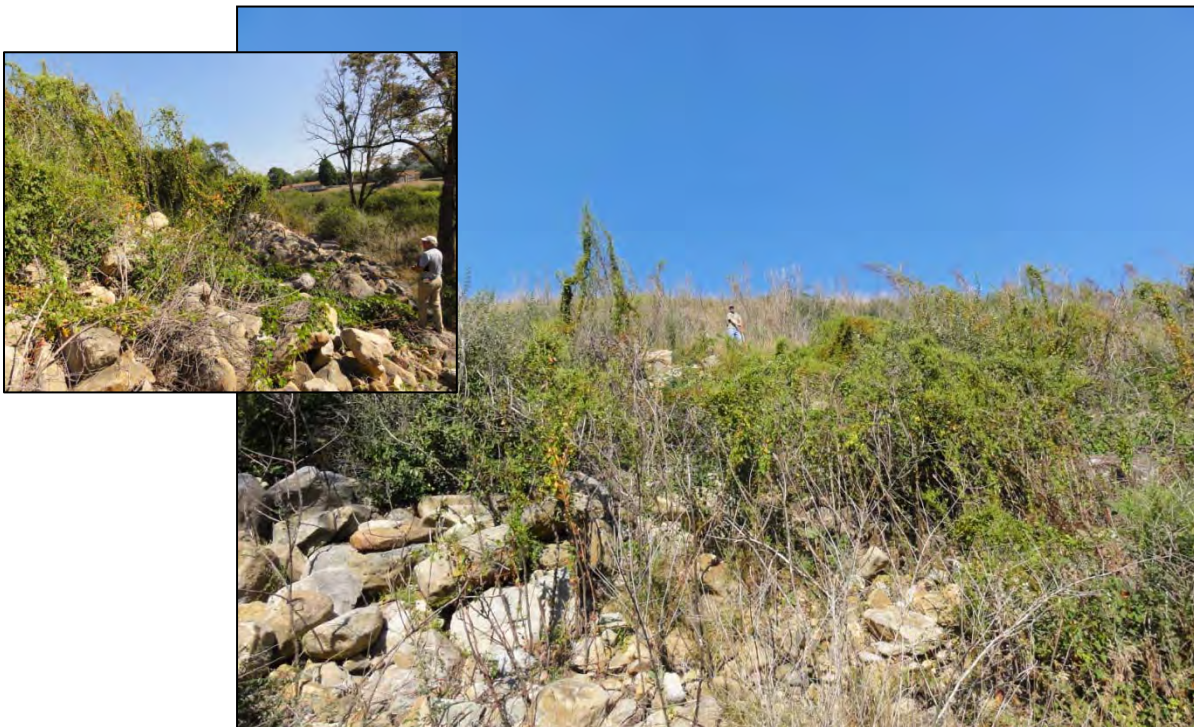
c. Rodent holes?	X			Near toe of embankment and principal spillway conduit outlet
d. Cracks, settlements, & bulges?	X			Areas of large cobbles appear to be irregular possibly due to creep

10. Woody vegetation on downstream embankment, especially in areas of large cobbles. Cobbled slope appears irregular due to overgrowth and possibly creep.

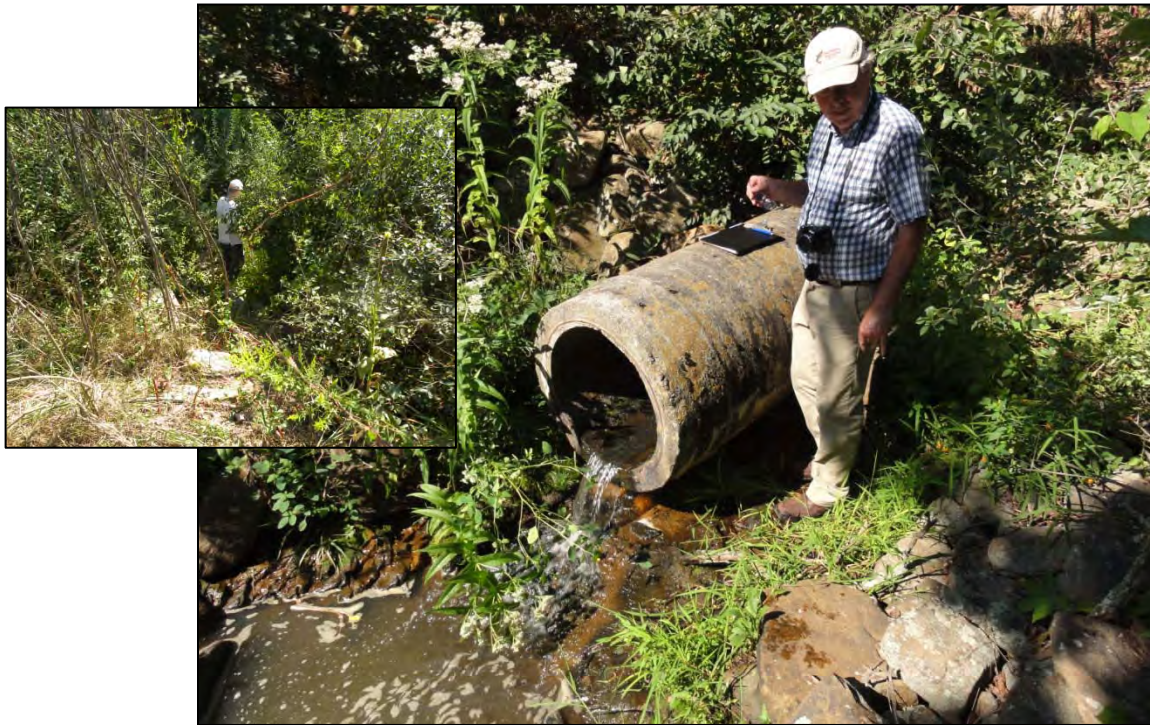
e. Leakage?				None observed. See Note 1.
f. Earth erosion?				None observed. See Note 1.
g. Conduit misaligned?				Not observed. See Note 1.
h. Outlet channel obstructed?	<input checked="" type="checkbox"/>			Thick vegetation around conduit outlet and plunge pool.
<b>8. Stilling Basin</b> Plunge Pool <input checked="" type="checkbox"/>

11. Plunge pool and outlet conduit are overgrown with vegetation.

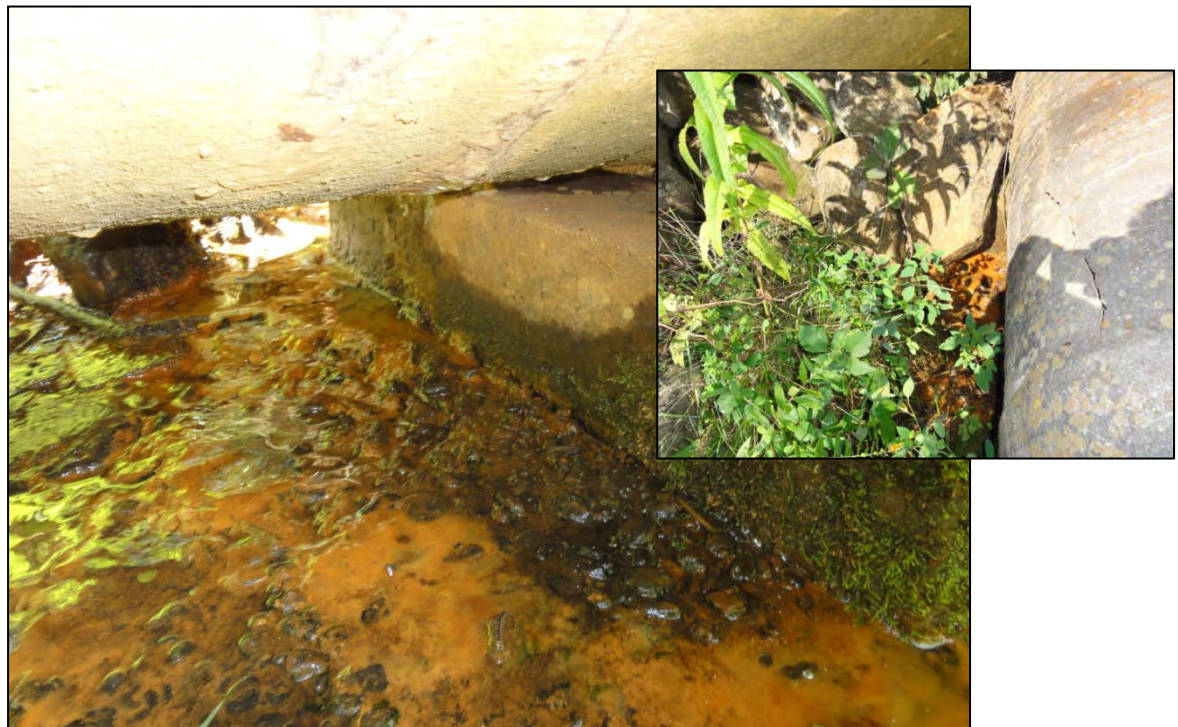
The principal spillway conduit outlet shows signs of significant deterioration including a fracture about 4 feet long. The outlet and plunge pool are surrounded and obstructed by thick, woody vegetation. A seep was observed beneath the cradle of the principal spillway outlet conduit. The seep was visibly flowing. No drains were observed at the site.

12. Seep around cradle beneath principal spillway conduit visibly flowing.

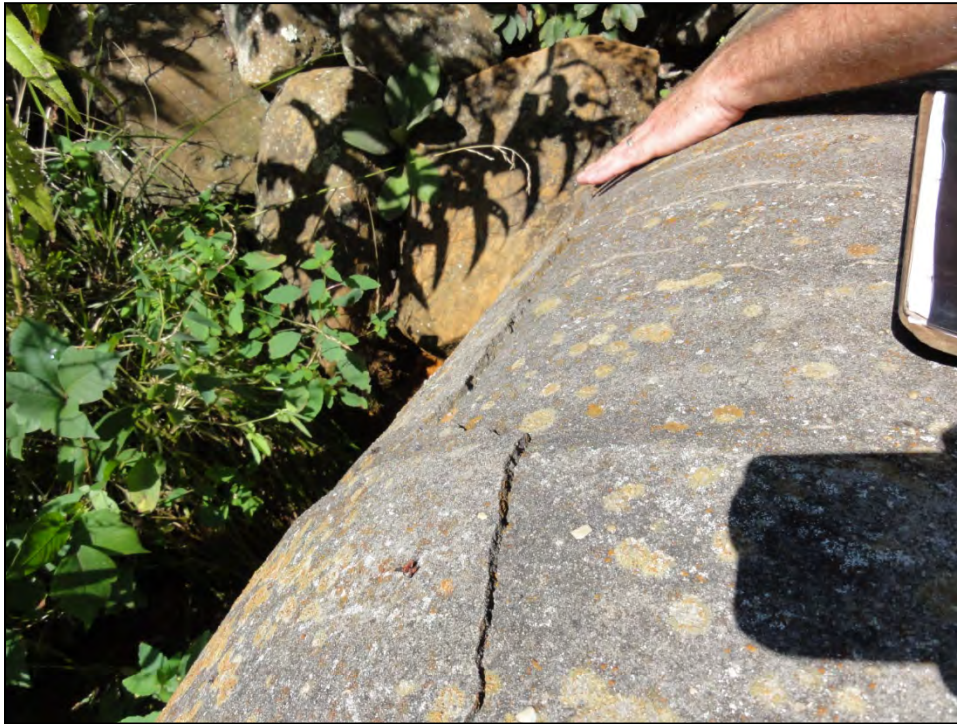
ITEM	Y	N	N/A	REMARKS
<b>7. Conduit &amp; Outlet</b> concrete <input checked="" type="checkbox"/> metal				tailwater elevation/flow
a. Spalling, cracking, & scaling?	<input checked="" type="checkbox"/>			~4-foot-long fracture observed on the principal spillway conduit outlet.

13. Significant fracture (~4 feet long) of principal spillway conduit outlet.

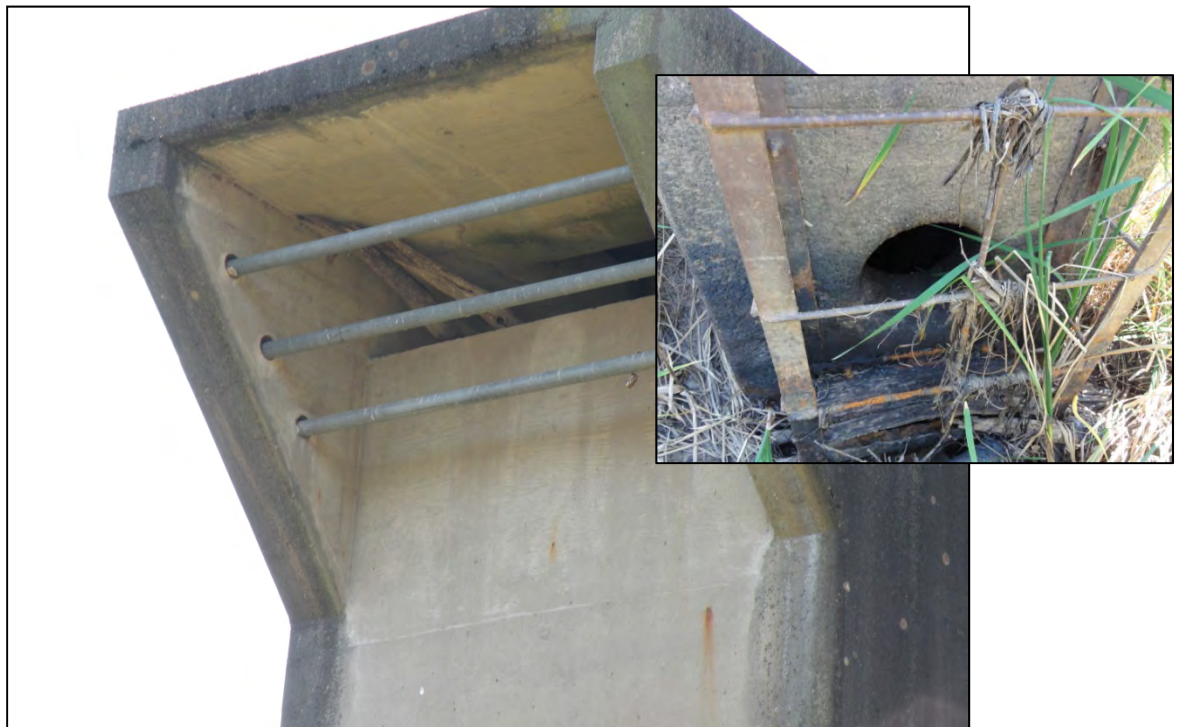
d. Manhole cover?	X			
e. Leakage?				estimated gpm      None observed. Interior not accessed.
f. Trash rack adequate?	X			
g. Inlet obstructed?	X			Minor debris surrounding lower inlet. Large branch lodged in riser structure.

14. Minor debris obstructing lower inlet of principal spillway. Large tree branch lodged in principal spillway riser structure.

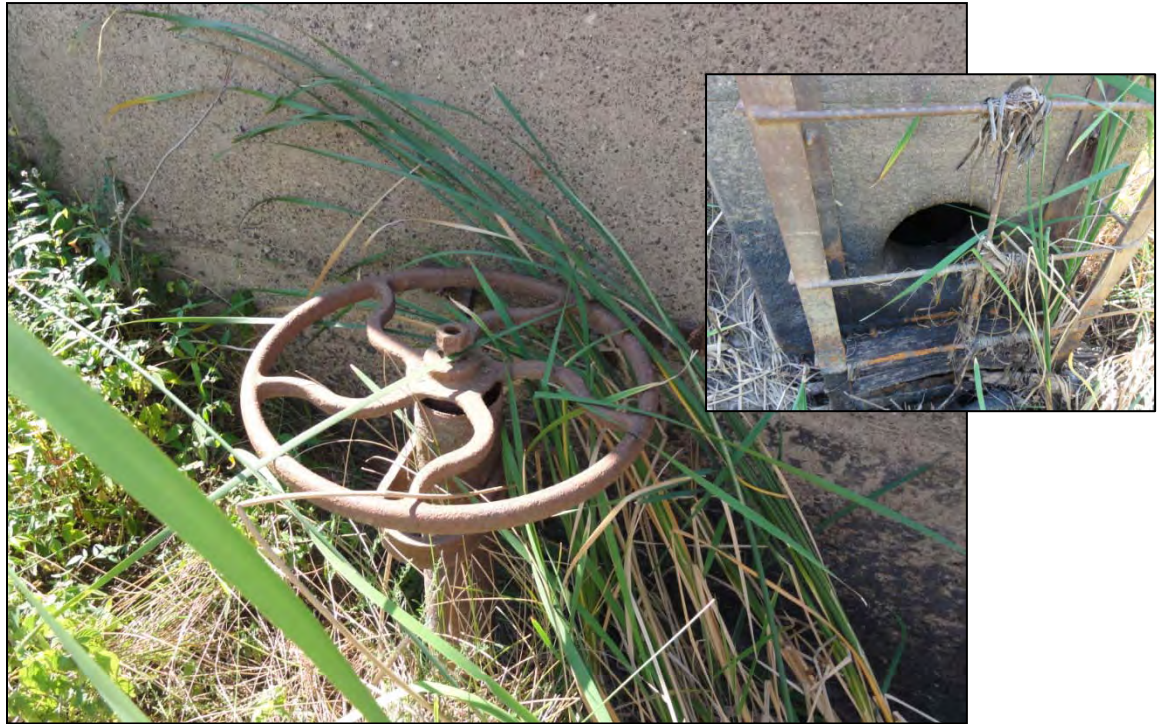
o. Do metal parts require painting?	X			Low level trash rack and drawdown handwheel
<b>5. Abutment Contacts</b>				
a. Erosion, cracks, or slides?		X		
b. Seepage?		X

15. Lower trash rack and drawdown gate stem and handwheel show signs of corrosion and need to be painted.

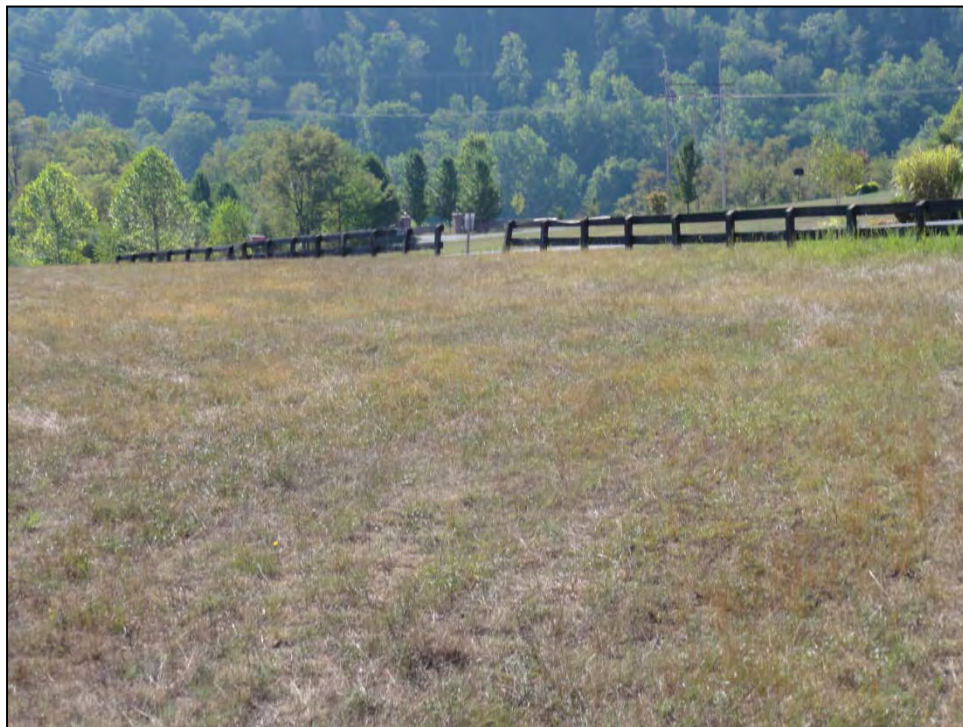
16. Small, wooden fence in auxiliary spillway channel.
