# **Riparian Buffer Assessment Final Report**

**An Inter-Agency Effort  
Summer 2009**

## **Abstract**

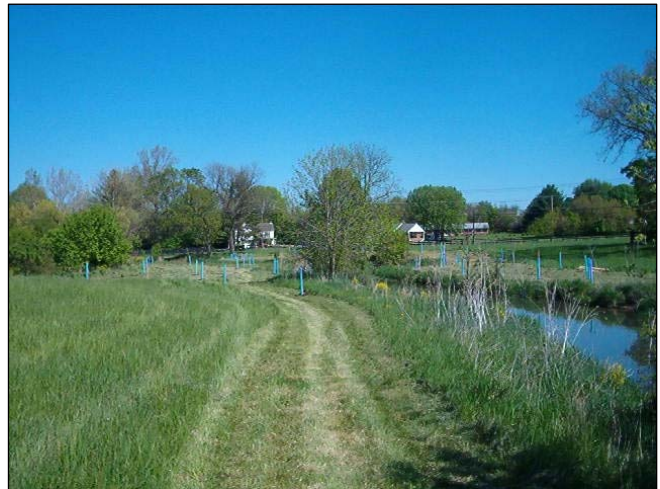
This planting was one of the first riparian plantings to be done by the OCPT. Trees were protected using 4-foot blue-X tubes. Combined, 415 trees and shrubs were planted initially. On August 13, 2009, only 80 trees and shrubs (29% survival) were recorded (Figure 17&18). Pines and oaks had survival rates of 18% and 9%, respectively, while tulip-poplar had only 8% survive. Conversely, sweet gum and silky dogwood each had greater than 40% survive which helped to raise the average survival rate of the site.

The main cause of mortality was species herbaceous competition and shading, since most trees and shrubs were surrounded by 6ft high weeds. Part of this site was also overwhelmed by Tree of Heaven (*Ailanthus altissima*), as it was not eradicated prior to planting.

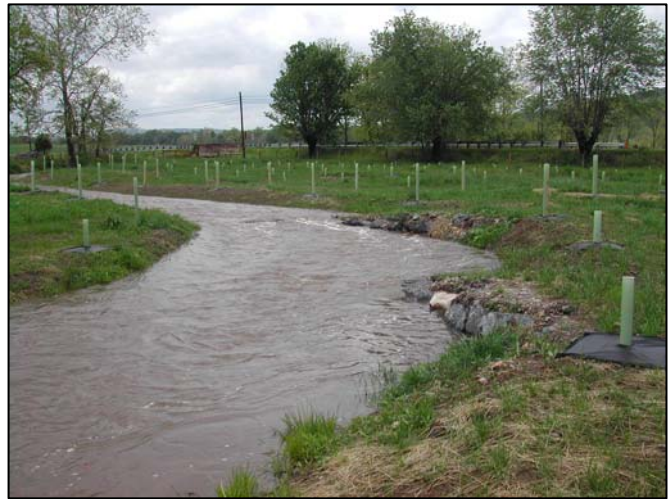
At the Wardensville site a total of 752 trees and shrubs were originally planted. On June 5, 2009, 278 trees and shrubs (47% survival) were recorded with the help of Jim Bowen (WVDOP), Carla Hardy (WVCA), Neil Gilles (Cacapon Institute) and other members of the WVDOP (Figure 23&24). Evergreens experienced the highest mortality (6% survival). The most likely cause was herbaceous competition and shading. It was also speculated that the visapore matting contributed to higher temperatures consequently killing the seedlings. However, if the outlying data from the pines is removed, the average survival rate jumps to 60% for the remaining species. Of those, hawthorn and black willow did the best, perhaps because their individual silvicultural characteristics make them better adapted to the site. Finally, some volunteer sycamores were found whose numbers, when added to those of the surviving planted individuals, helped to balance the mortality.

The mortality which did occur on the other species may be accounted for by groundhog damage in some areas and herbicide spraying along the road. Additionally, many of the wooden stakes which support the tree shelters were rotted. When these fail and the shelters fall, the rate of mortality increases greatly.

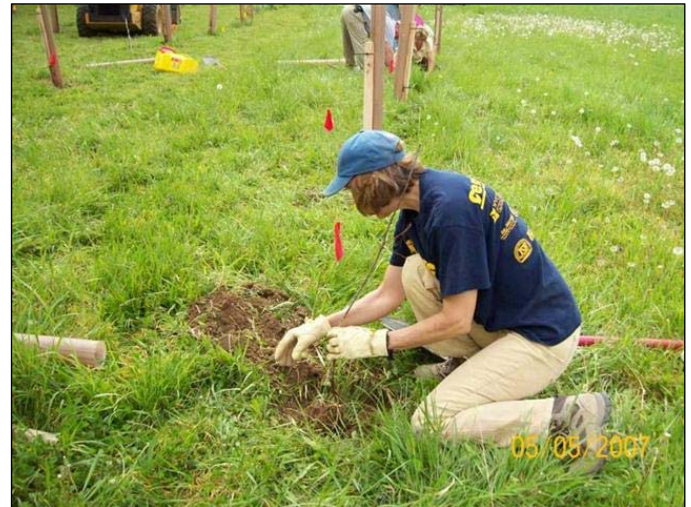
At the site, 140 bare root trees and shrubs were initially planted. Holes were pre-augured, and trees were mulched and watered. Four foot brown tubes were installed on all except for the white pine. According to the landowner, 20% mortality occurred in the first year due to dry conditions. Subsequent floods destroyed some of the tubes which led to deer damage and increased mortality. The landowner speculated that other mortality was caused by poor planting technique including potential root desiccation. Only 90 trees (64% survival) were recorded on June 16, 2009 during this assessment (Figure 11&12). By landowner accounts, deer browse seemed the predominant cause of mortality for the white pine. Deer browse was heavy on the sheltered trees as well. Only a few trees had growth above the top of the 4 foot tube. Additionally, many of the oaks, while alive, were showing signs of a chlorophyll deficiency. The netting on the tops of the tubes was deteriorating.

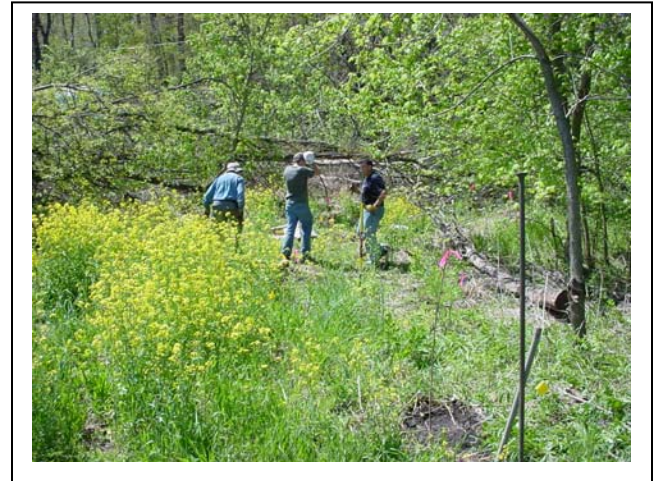
Forty-five trees and shrubs were planted by hand at the Staubert site. Although the trees/shrubs were originally protected by cages and/tubes, these protection devices were not present during the assessment on July 13, 2009 (Figure 19&20). Twenty-two trees and shrubs were reported (51% mortality), and they were shaded by established trees. Many planted trees could not be found but may have blended in with the landscape. The site was quite shady and it is possible that some of the mortality was due to lack of sunlight and flooding. None of the oaks survived or could be found and, unlike the previous assessments, black willow did not do well here. There were many volunteer plants that had sprouted, however.

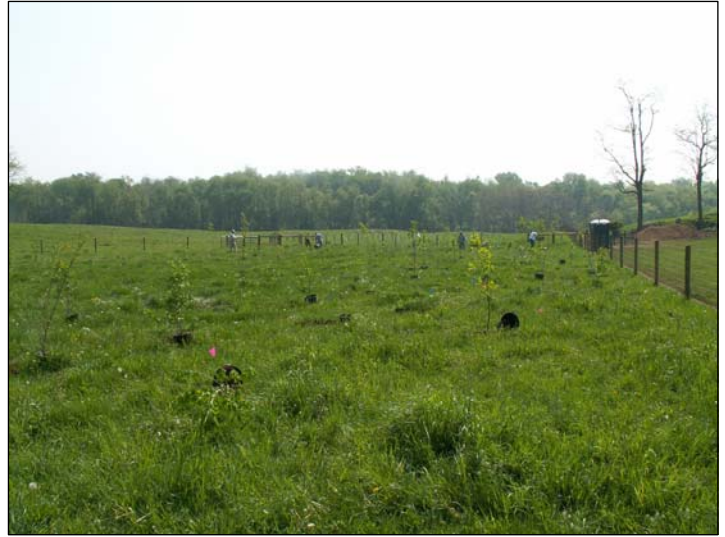
This planting was done with larger container stock, making it impractical to install tubes or cages. The holes were pre-augured and the planting was done by experienced volunteers from the CBF. Out of the 909 trees and shrubs initially planted, 828 were recorded (91% survival) on June 15, 2009 (Figure 3&4). The assessment was completed 1 ½ growing seasons after the planting. Small rodent damage, either by bark girdling (voles) or root damage, was one of the two predominant causes for mortality (7%). The second cause was natural (5%) probably due to some water stress amid heavy grass competition.

There was certainly deer present in the planting area. Deer rubbing damage was high on the white pine, although most survived. Other rubbing damage occurred on the red maple and tulip poplar. Browse damage was light. Shrub survivability overall was high. Sycamore and swamp white oak survival was strong again and red maple, although showing deer rubbing damage, survived at 100%.

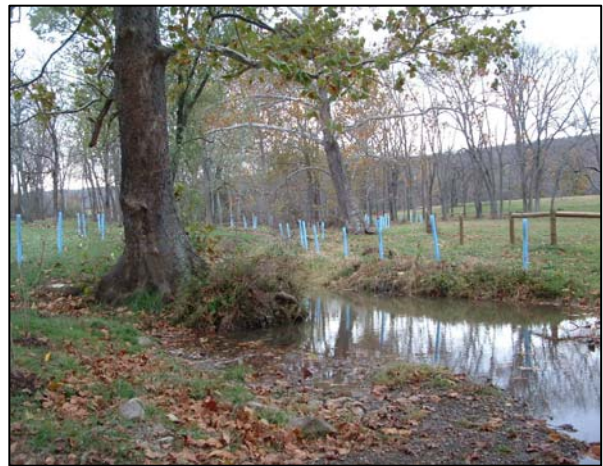
At the Conley site, 166 trees and shrubs were planted. During the assessment on June 25, 2009, 146 trees and shrubs were recorded, a survival rate of 88% (Figure 5&6). Tulip poplar had the lowest survival rate (60%) of the tree species, while, among the shrubs, Red osier dogwood was the lowest (73%). Insect (5%) and deer browse (4%) were the two main causes of damage on site. Oak trees were most damaged by the deer. Also many of the metal stakes were bent from high water, which probably contributed to the mortality rates observed.

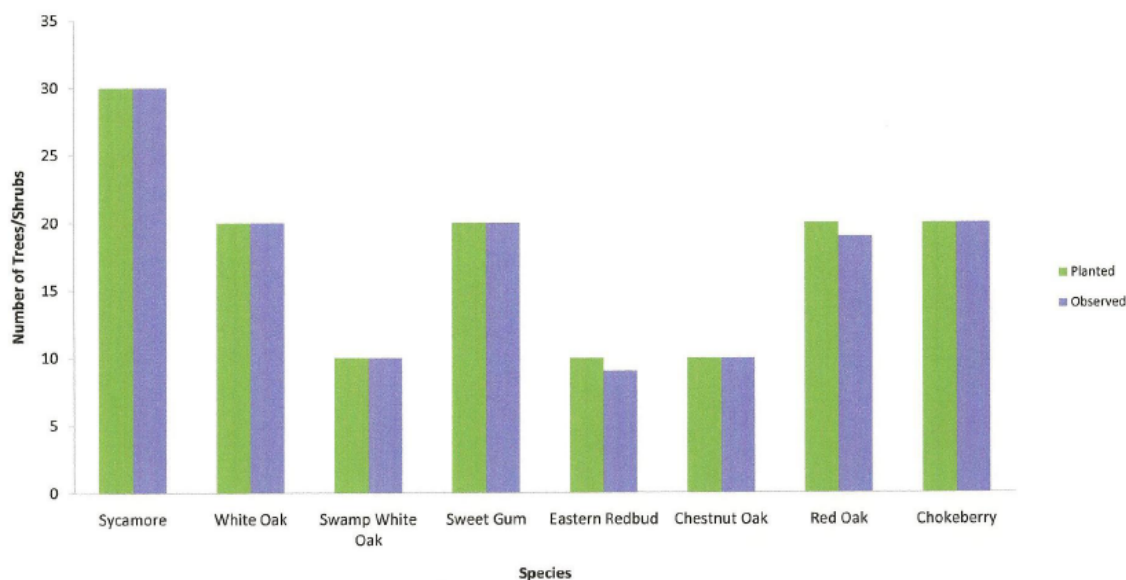
Figure 9. Species Counts for Foulds/Dawson Site

The Foulds/Dawson site was planted by experienced volunteers. The holes were pre-augured and container seedlings were used. This planting was one of the more recent ones and had a 99% survival rate at the time of our assessment. 140 trees and shrubs were planted, and 138 were recorded in outstanding condition on July 13, 2009 (Figure 9&10). Japanese beetle (*Popillia japonica*) damage to all of the Sycamore trees, similar to what was found at the nearby Dawson site was a major source of damage. Also noted was some deer browse, but on only selected species of trees

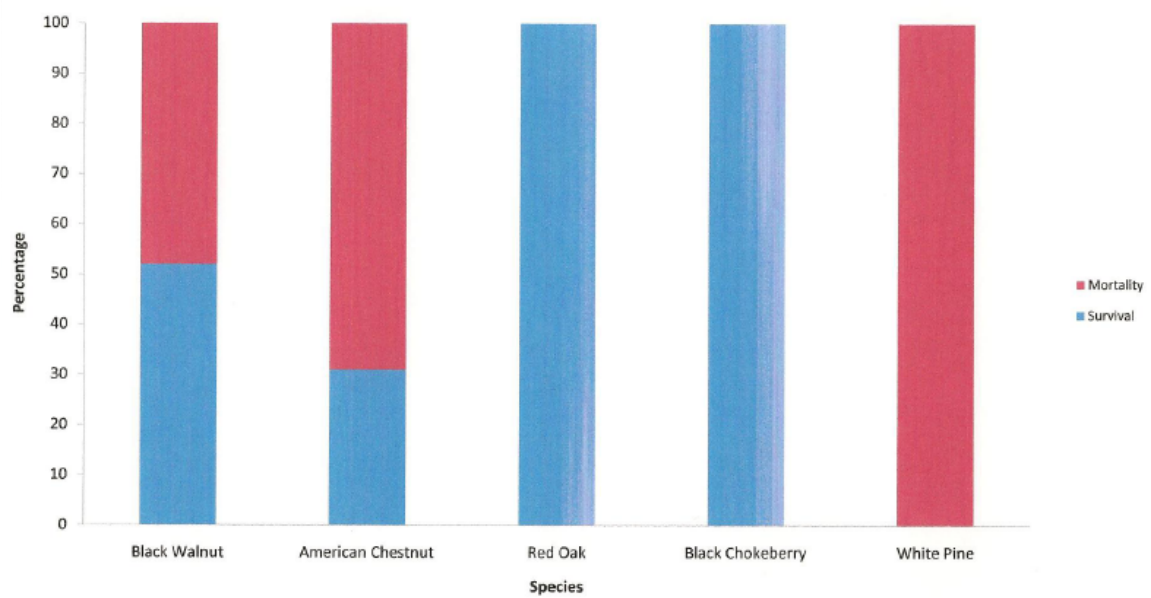
**Figure 12. Species Mortality/Survival Jacko**

Netting- deteriorating; Landowner said that many plants were not planted properly; the Red Oaks and pin Oaks were found to have a chlorophyll deficiency; Deer browsing was found on most walnuts and red oaks; flooding occurred at the site

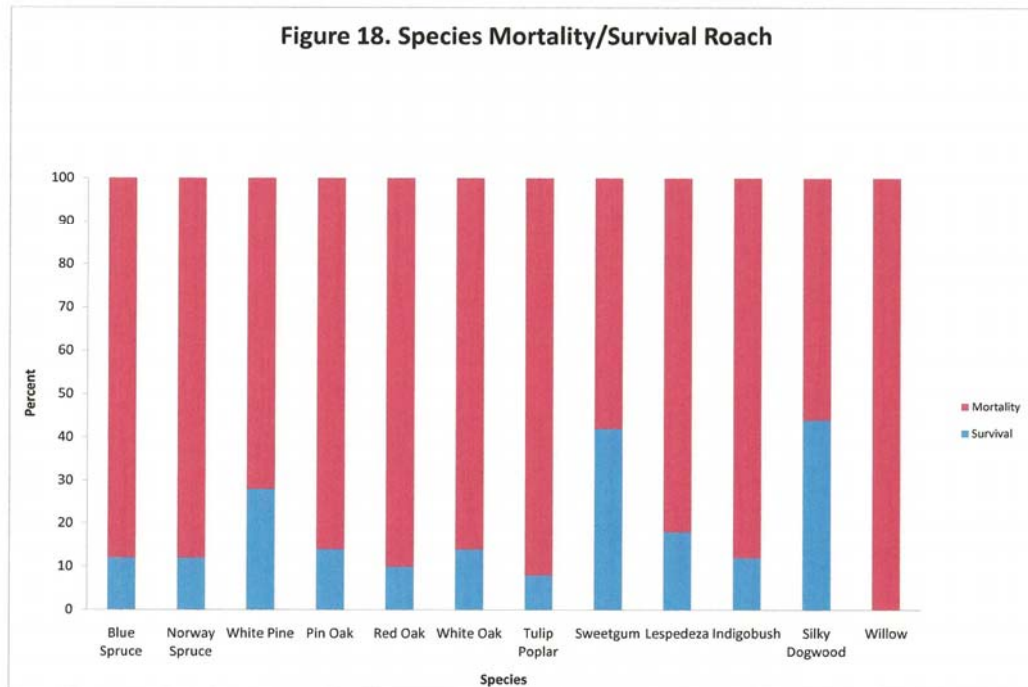
Figure 18. Species Mortality/Survival Roach

Far side of planting doing well, still tubed; Dogwoods need to be caged- lots of browse; Wooden stakes are rotting; Tree of Heaven in many patches; Major competition brought on by thistle, tree of heaven, and honeysuckle; Lots of volunteer Box Elder, Walnut, Pear, Ash, and Black Locust

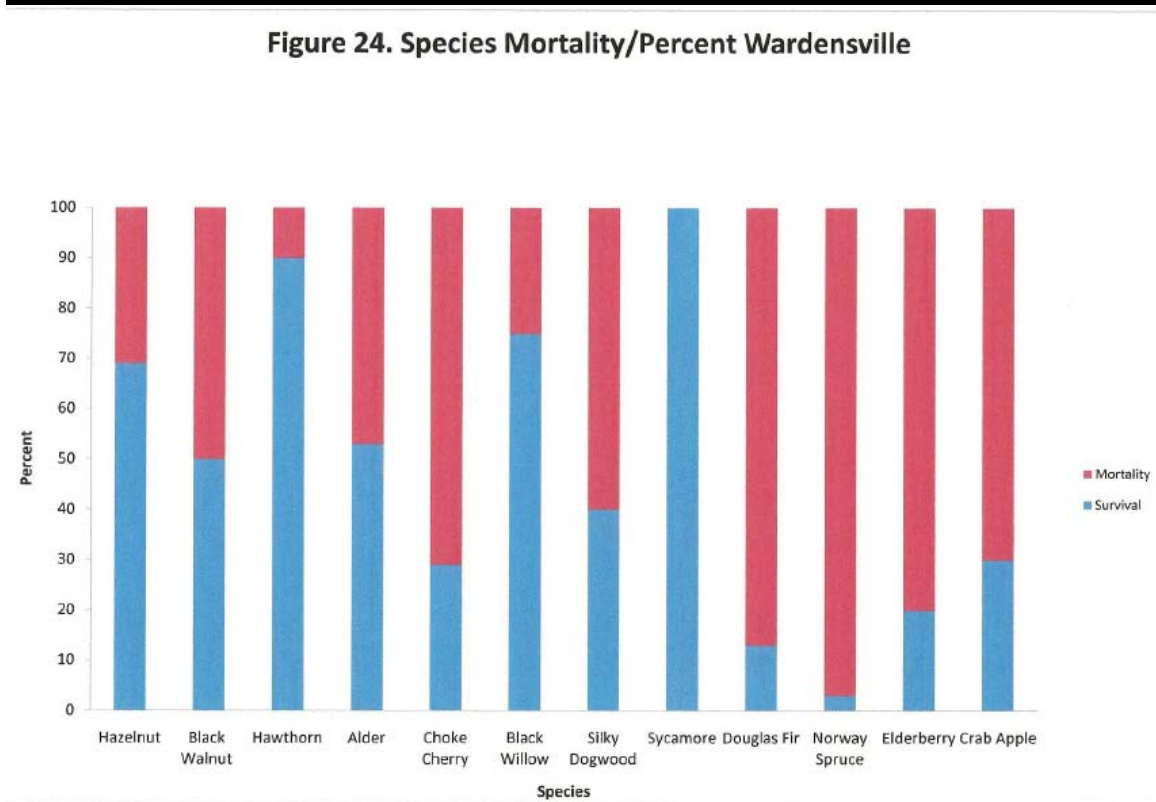
Figure 24. Species Mortality/Percent Wardensville

Stakes need to be replaced on many tubes. Black walnut recruits, 4 bald cyprus, and 17 chinese chestnuts were on site, but not measured. The douglas fir trees are total height, no tubes. The Human damage is due to herbicide being sprayed on the fence line.
