# REHABILITATION ASSESSMENT REPORT

## Brush Creek Watershed Site 15

Mercer County, West Virginia

**March 2011**

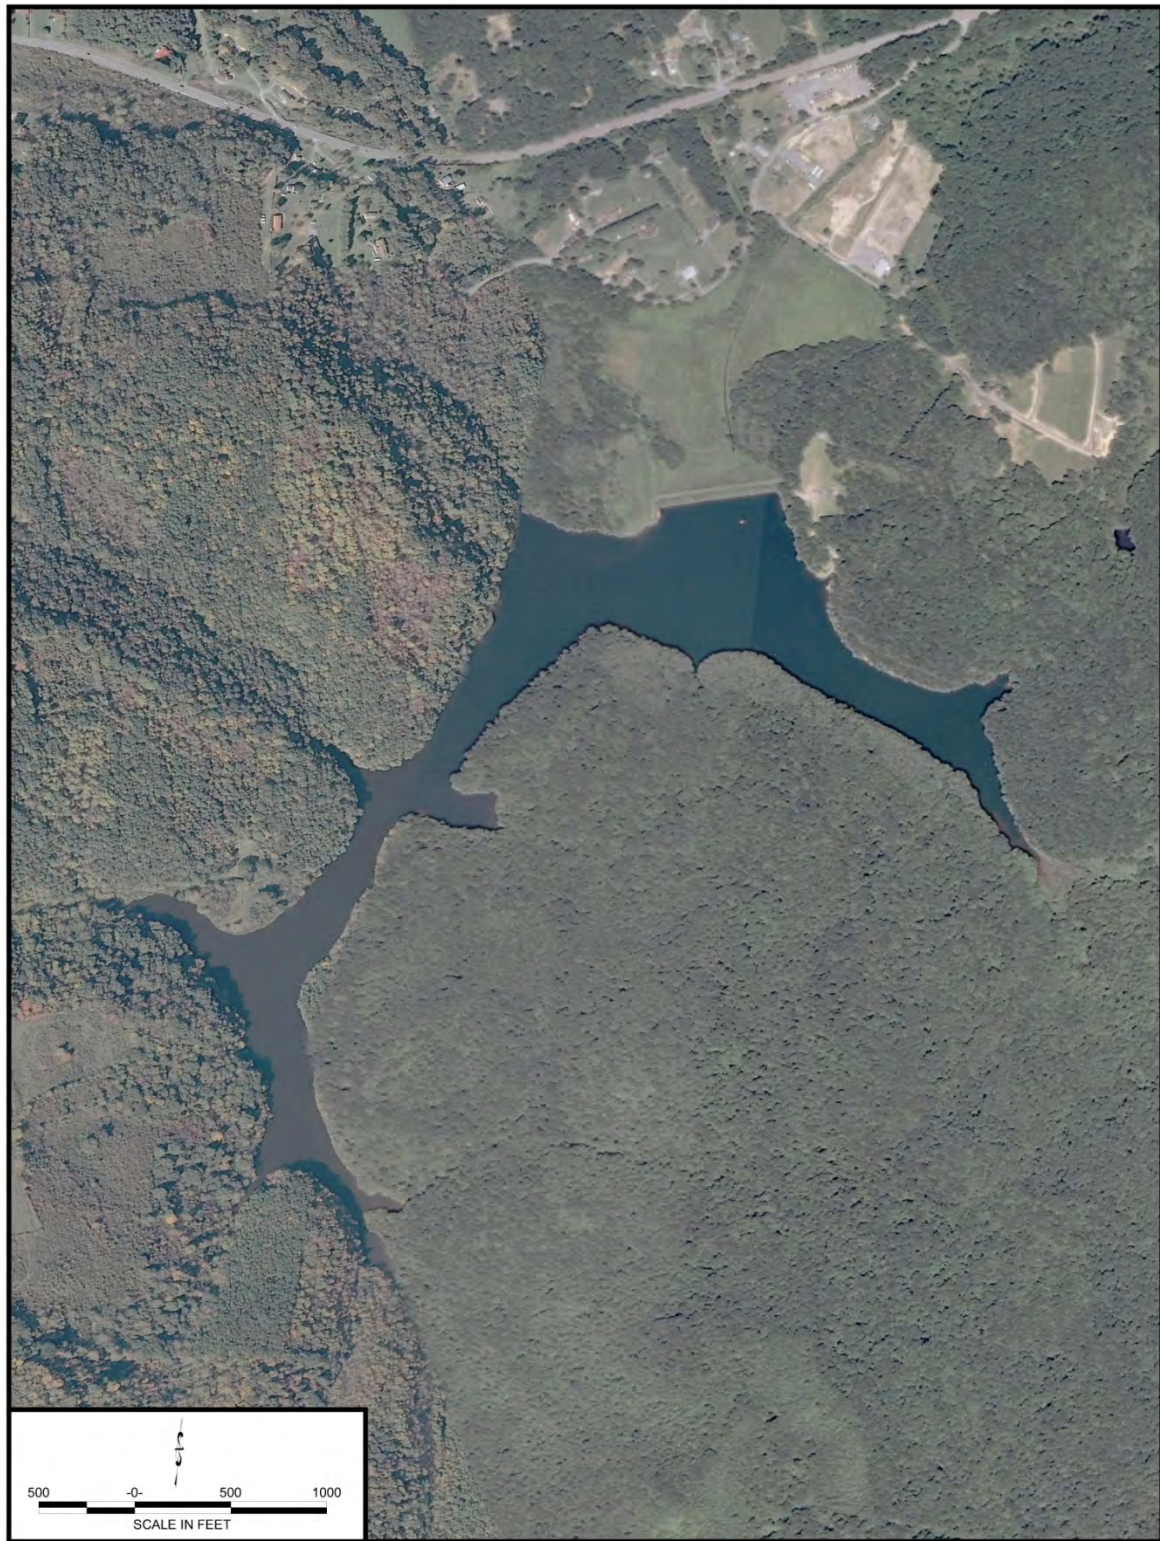
Figure 1. Aerial Photo of Brush Creek Site 15

Brush Creek Site 15 is located on North Fork of Brush Creek in Mercer County approximately 5.5 miles from Princeton, WV. The location of Brush Creek Site 15 is shown on the Project Map for the Brush Creek Watershed presented on Exhibit 1. An aerial photo and USGS quadrangle of Brush Creek Site 15 are presented on Figures 1 and 2, respectively.

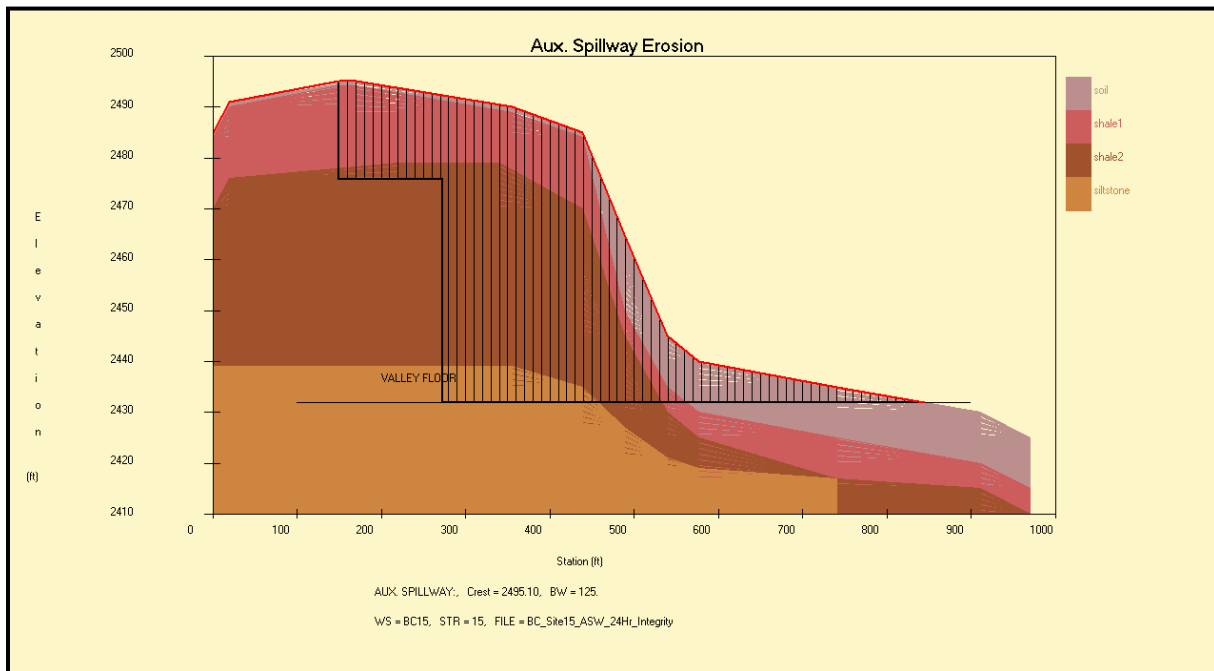
Figure 3. Plot of Auxiliary Spillway Profile and Extent of Erosion from Integrity Analysis for 24-hour Class C Freeboard Hydrograph (PMF) Obtained from SITES Model Output

The SITES auxiliary spillway analysis shows that the auxiliary spillway will completely breach during passage of the 6-hour FBH. For the long duration 24-hour storm, the analysis also shows complete breaching of the auxiliary spillway. The SITES output for both the 6-hour and 24-hour storms for as-built, Class C criteria are presented in Appendix C. The electronic input files for the SITES model are furnished in the Supporting Data Folder on a CD.

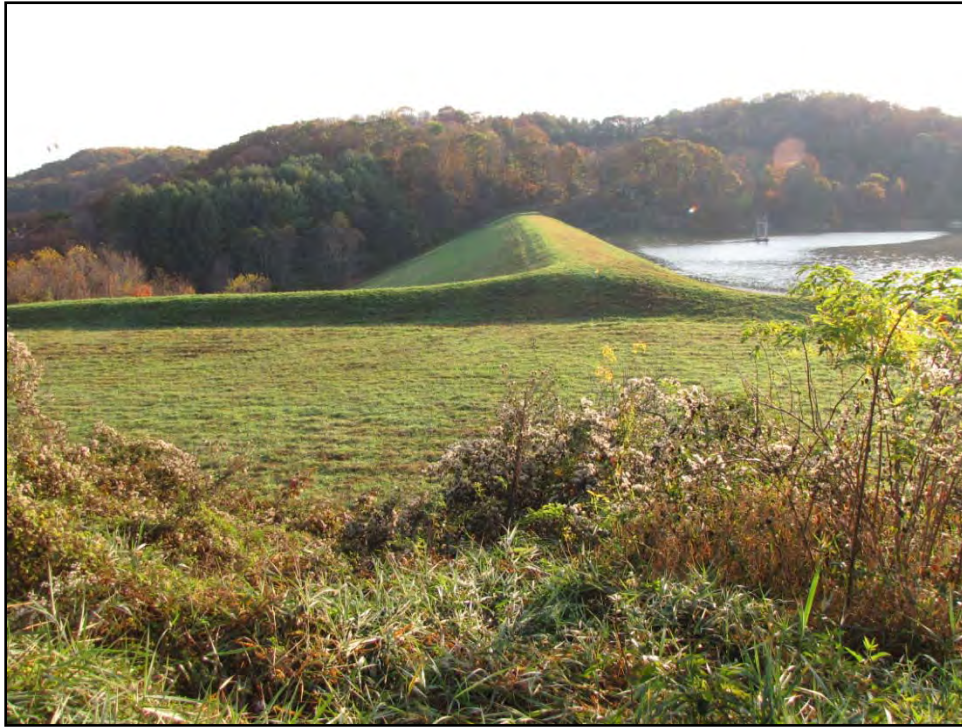
1. General overview of dam from left side of auxiliary spillway.

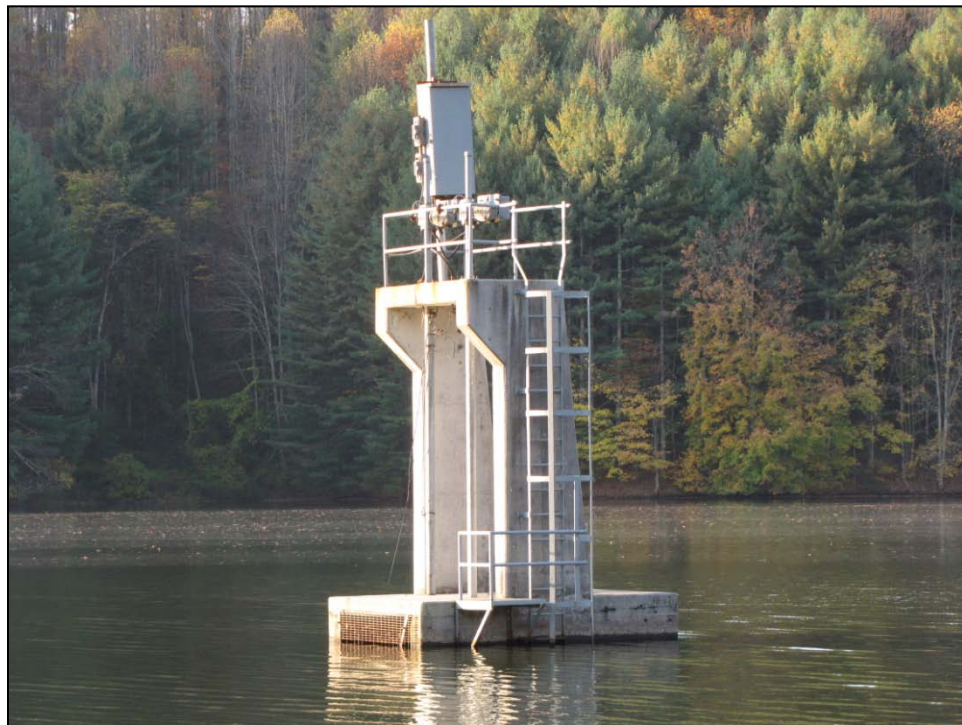
The concrete principal spillway riser structure and stilling basin appear to be in good condition and operating as designed. No external evidence of cracking or deterioration was observed.

2. Principal spillway riser structure.

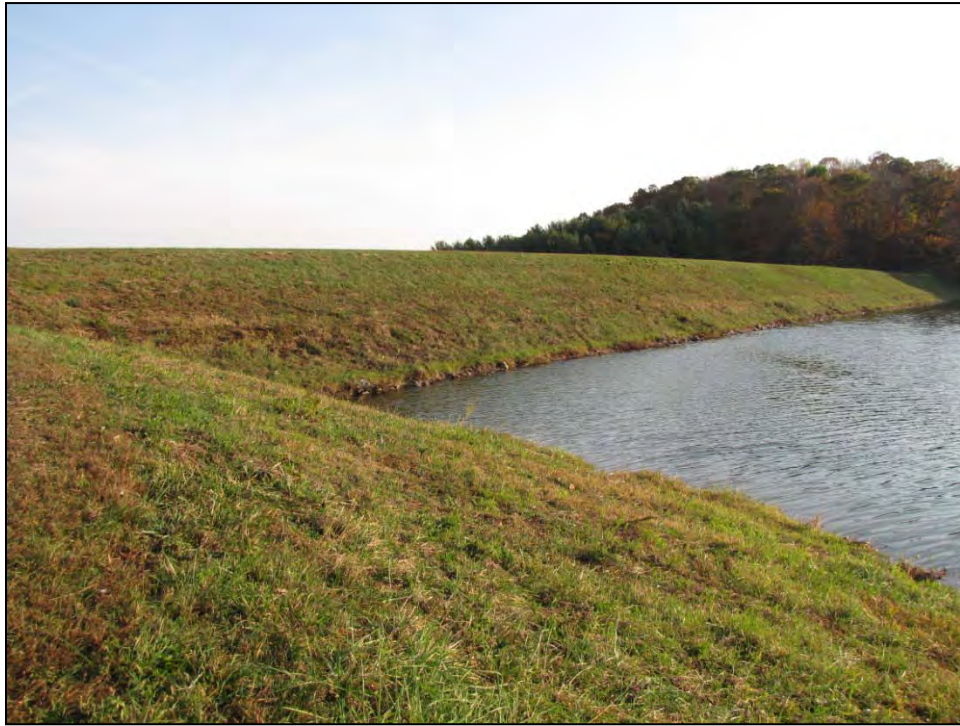
3. Upstream embankment slope.

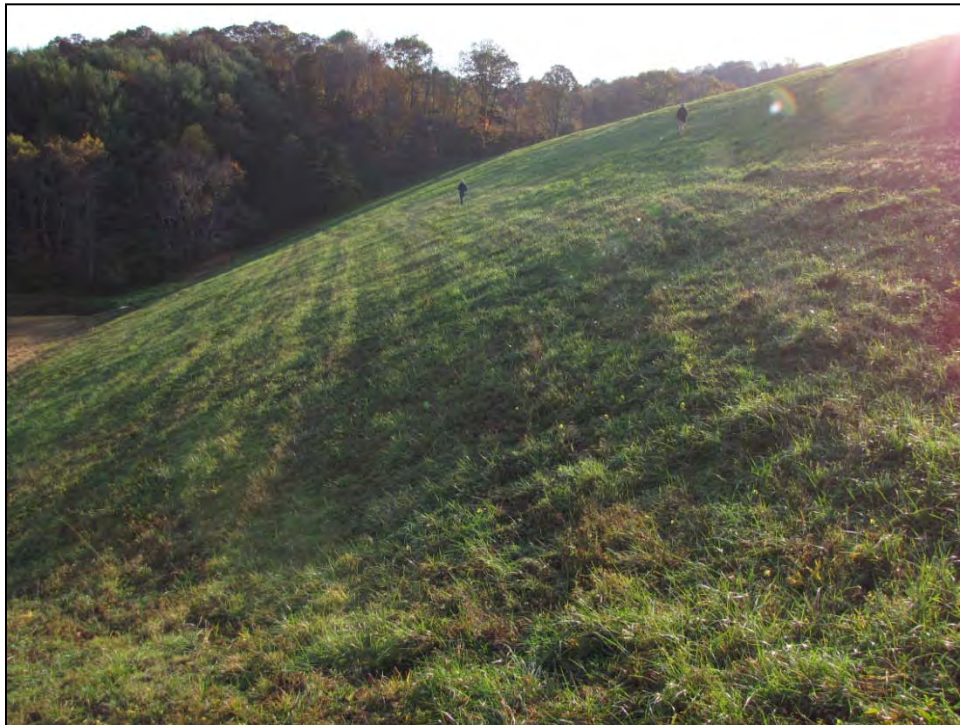
4. Downstream embankment slope.

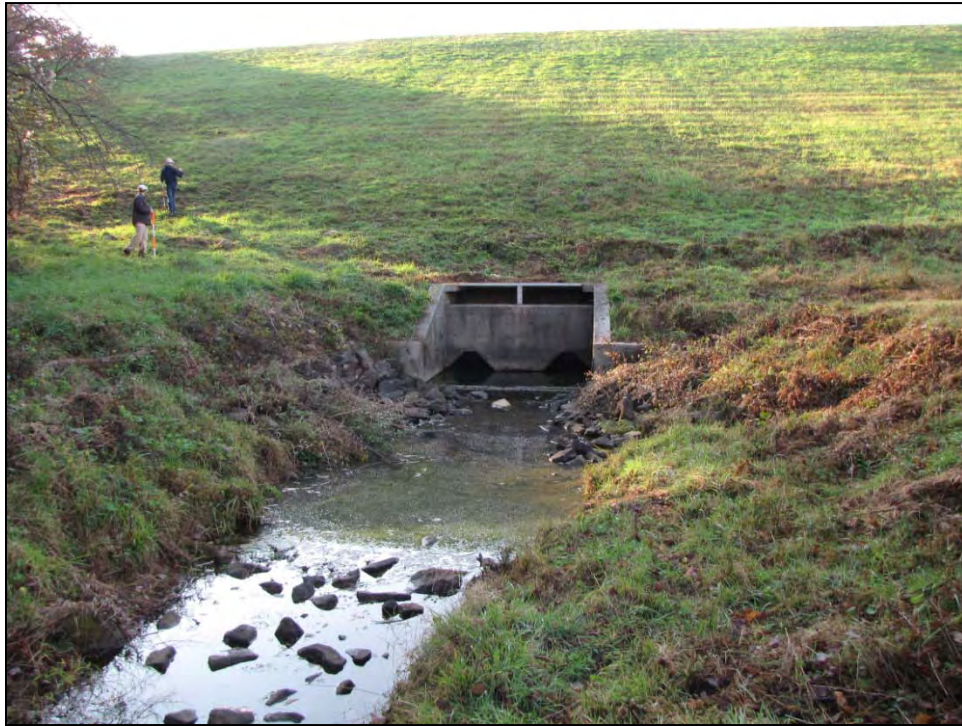
a. Spalling, cracking, & scaling?		<input checked="" type="checkbox"/>		Concrete shows signs of weathering
b. Exposed reinforcement?		<input checked="" type="checkbox"/>

f. Rock adequate?	<input checked="" type="checkbox"/>			
g. Dissipater deteriorating?		<input checked="" type="checkbox"/>		Minor weathering
h. Dissipater clean of debris?	<input checked="" type="checkbox"/>

5. Outlet channel and stilling basin.

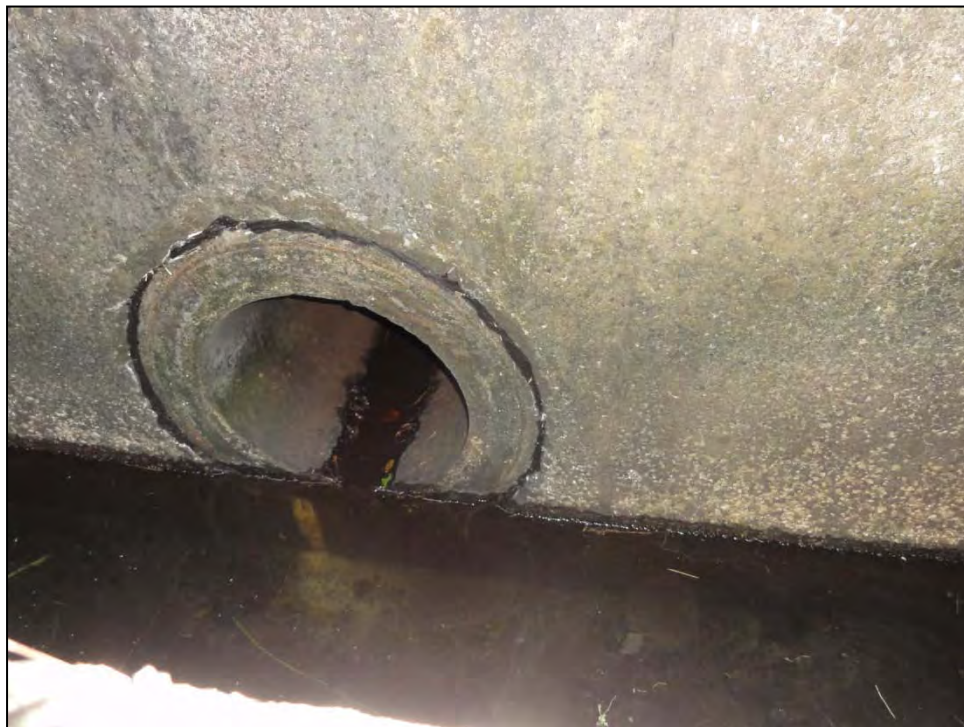
In addition to the site inspection, video inspection of the principal spillway conduit as provided by the NRCS was reviewed. The ROVER inspection of the principal spillway conduit was performed on September 10, 2002 and revealed minor wear of the concrete lining throughout and slight joint separation at a joint located approximately 81 feet from the conduit outlet.

6. Outlet conduit.

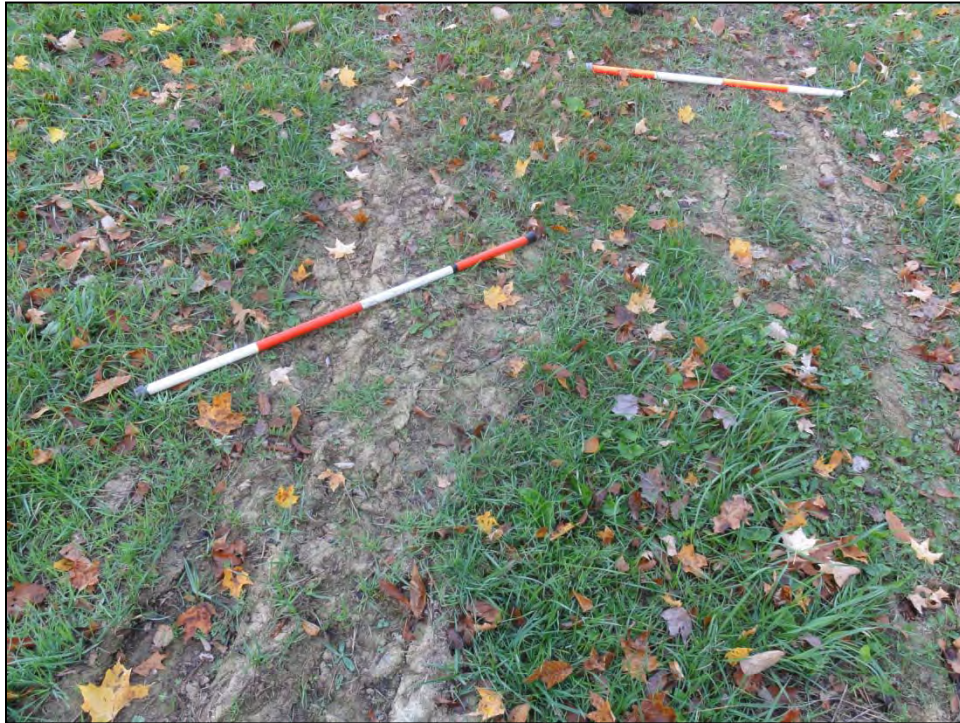
The grass cover on the upstream and downstream slope of the dam embankment was found to be adequate. However, there were several areas of erosion including some minor tire ruts on the crest on the dam and an erosion gully beginning to form in the left downstream

7. Tire ruts along crest of dam.

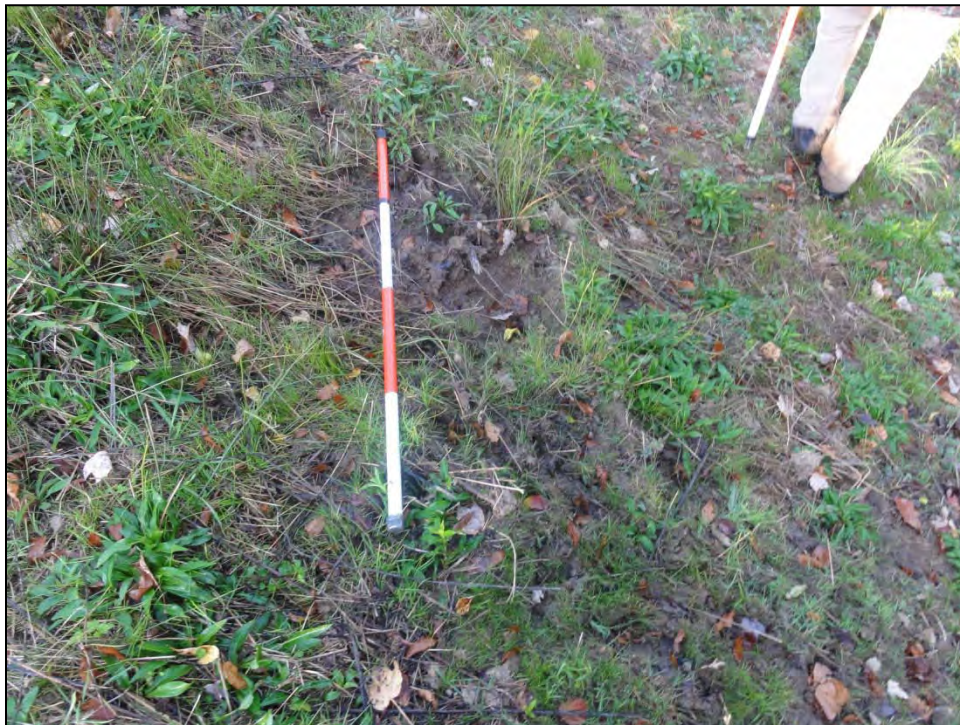
The CMP drains located on either side of the principal spillway outlet conduit were both flowing at a combined flow of less than ½ gpm. A wet area was observed near the downstream toe and right gutter of the dam. Otherwise, no signs of embankment instability or seepage were observed.

e. Drains or wells flowing?	X			estimated gpm Both drains flowing (combined flow less than 1/2 gpm)
f. Seepage or boils?	X			estimated gpm Wet area observed near right gutter and toe
<b>4. Intake Structure</b> concrete X metal				water surface elevation

8. Wet area observed on right side of downstream slope.

Items of deferred maintenance include seeding bare areas, repairing areas of wave erosion, and armoring the left downstream abutment contact. The wet area on the right side of the downstream slope should also be regularly monitored.

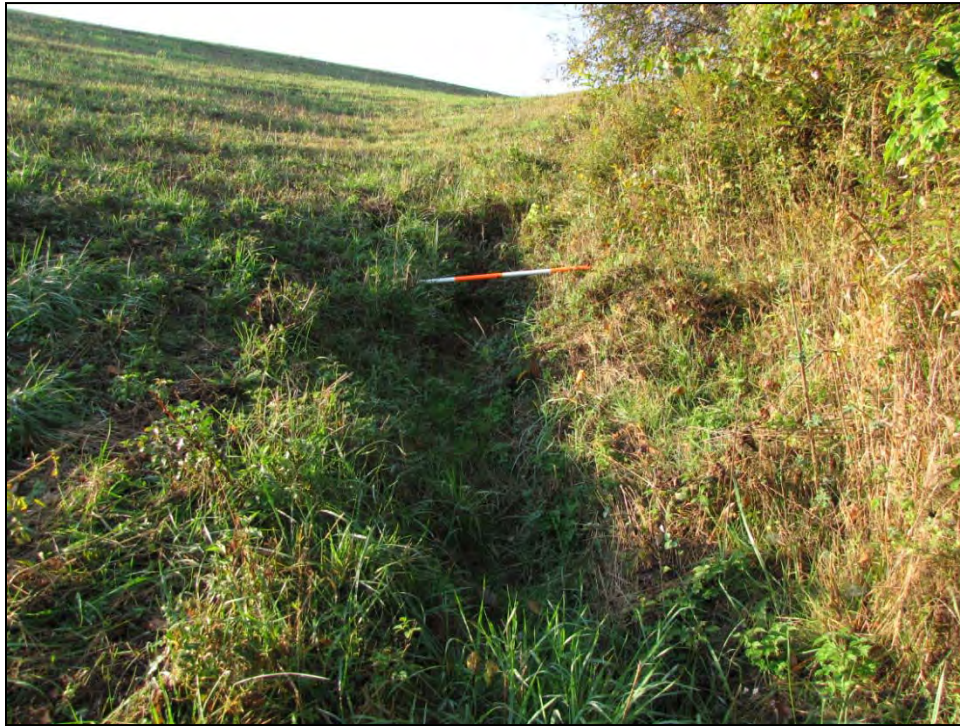
a. Erosion, cracks, or slides?	X			Erosion gully beginning to form in left downstream abutment contact.
b. Seepage?		X		
c. Gutters intact?	X			
<b>6. Auxiliary Spillway</b>

9. Erosion gully forming in left downstream abutment contact.

- 11.1 Operations and Maintenance.** Brush Creek Site 15 was observed to be in good condition with several maintenance deficiencies that need to be addressed. These include seeding bare areas, repairing areas of wave erosion, and armoring the left downstream abutment contact. The wet area on the right side of the downstream slope should also be regularly monitored.

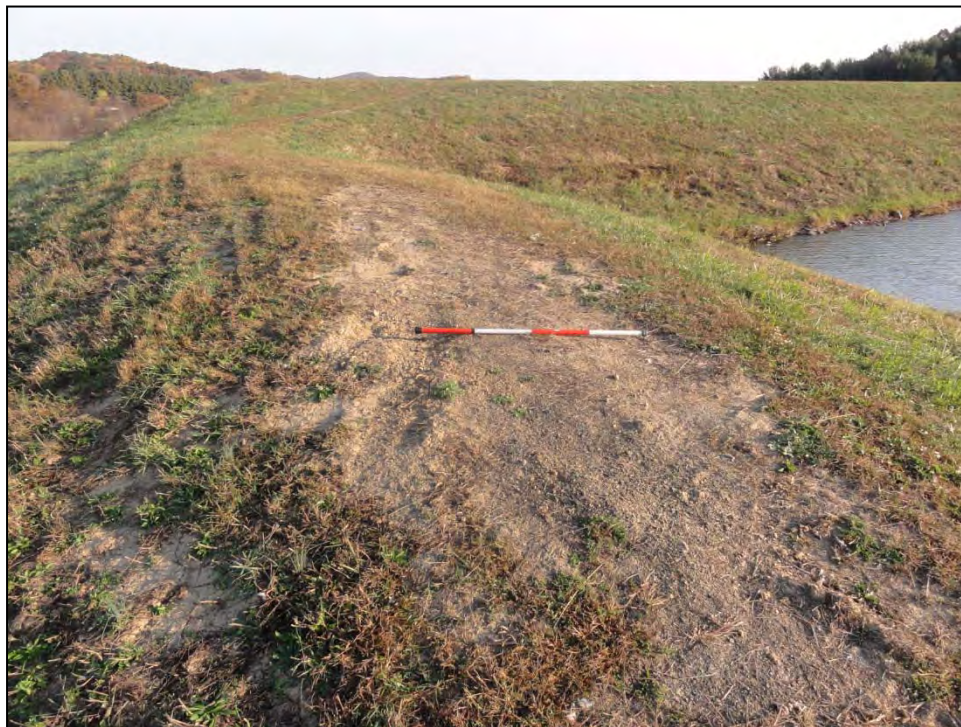
Wave erosion at normal pool level also extends into the upstream slope of the auxiliary spillway. A few bare areas within the upstream slope and training dike of the spillway were also observed.

10. Bare area near inlet of auxiliary spillway.

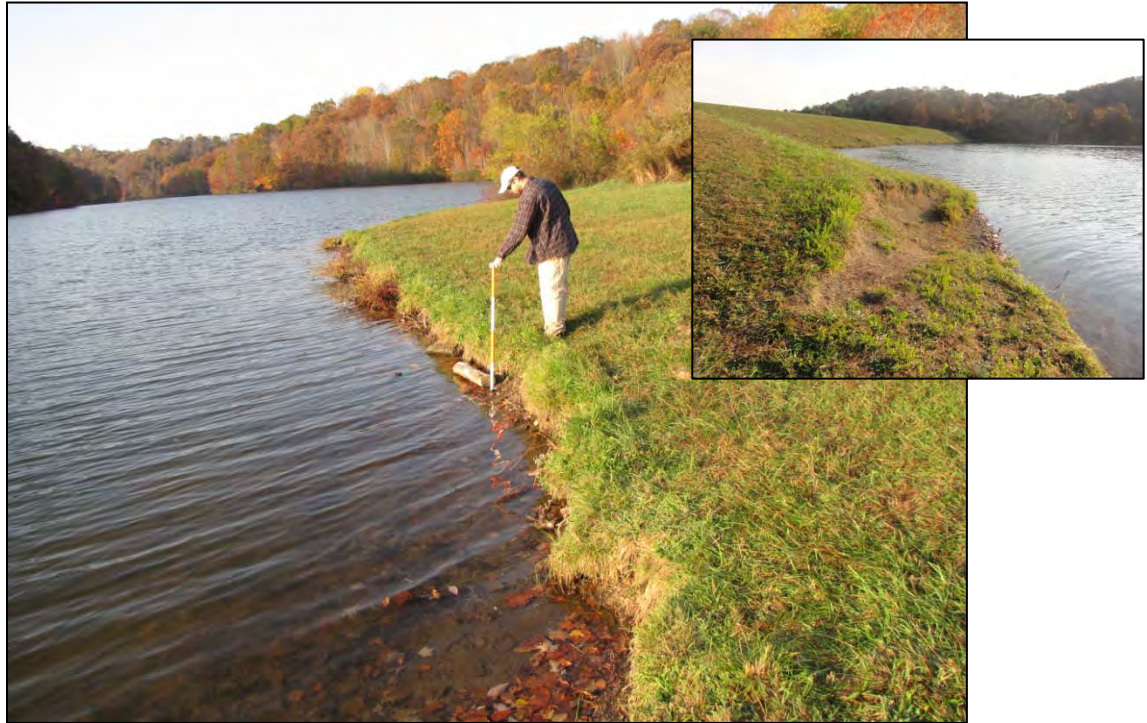
a. Erosion?	X			Wave erosion at normal water level.
b. Trees?	X			Tree stumps in embankment.
c. Rodent holes?		X		
d. Cracks, settlements or bulges?	X			Wave erosion at normal water level.

11. Wave erosion on upstream slope of embankment and auxiliary spillway.

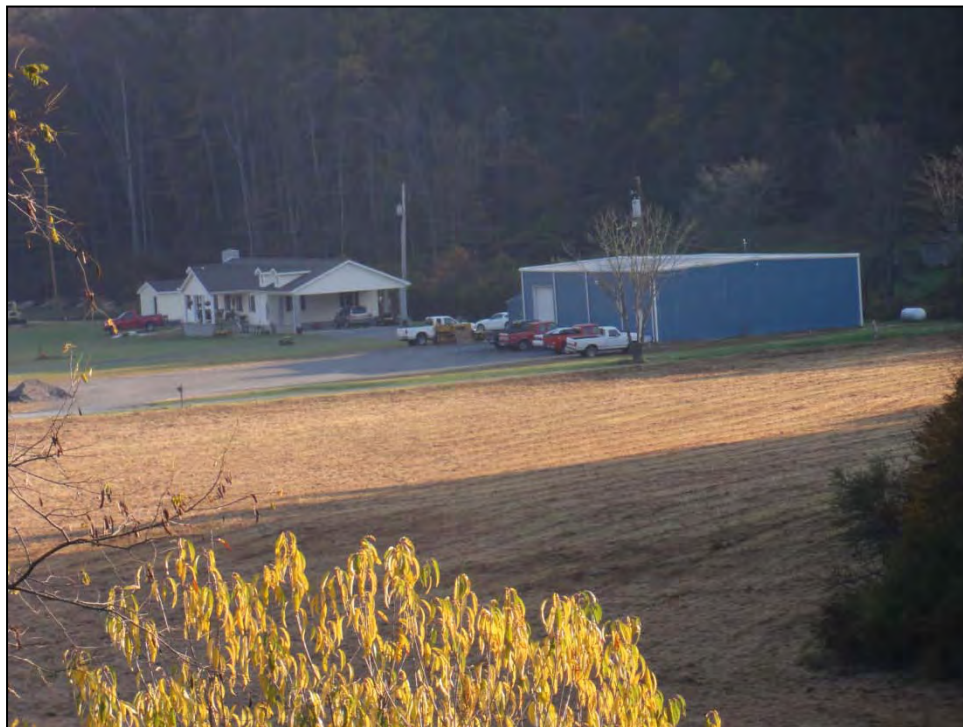
b. New development downstream of dam?	<input checked="" type="checkbox"/>			New houses immediately downstream of dam.
c. EAP plan and mapping adequate?				To be determined by others.
<b>12. Hazard Classification Correct?</b>	<input checked="" type="checkbox"/>

12. Recently constructed house and other buildings immediately downstream of dam.

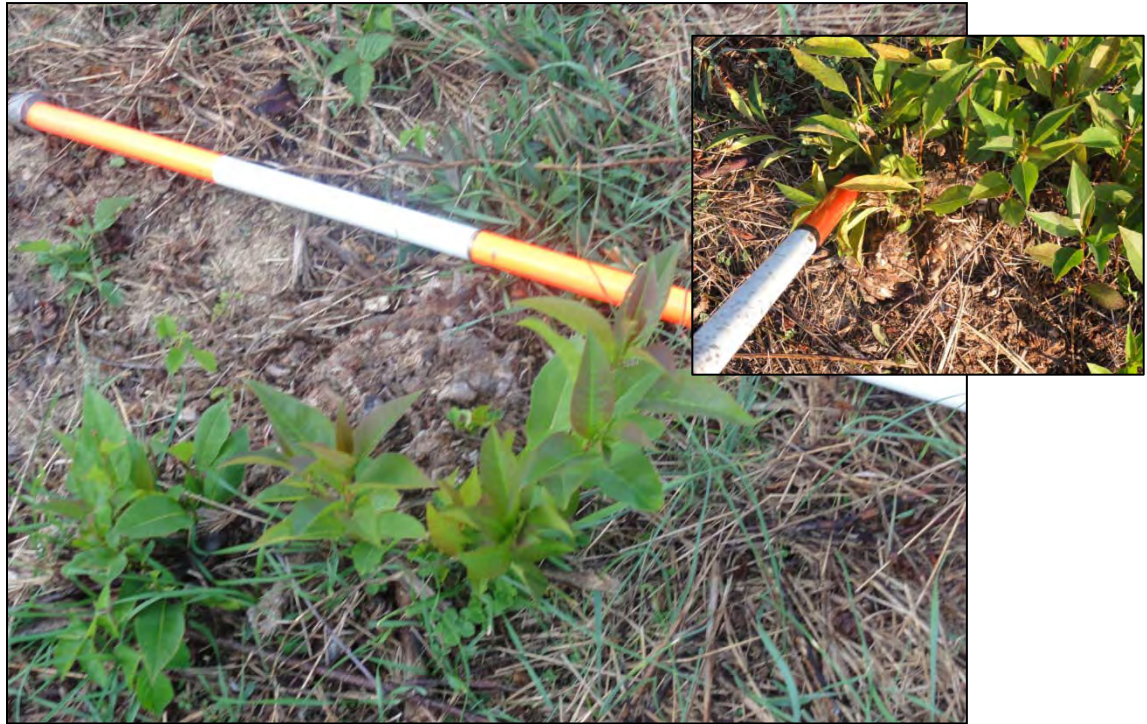
13. Tree stumps in upstream slope of embankment.

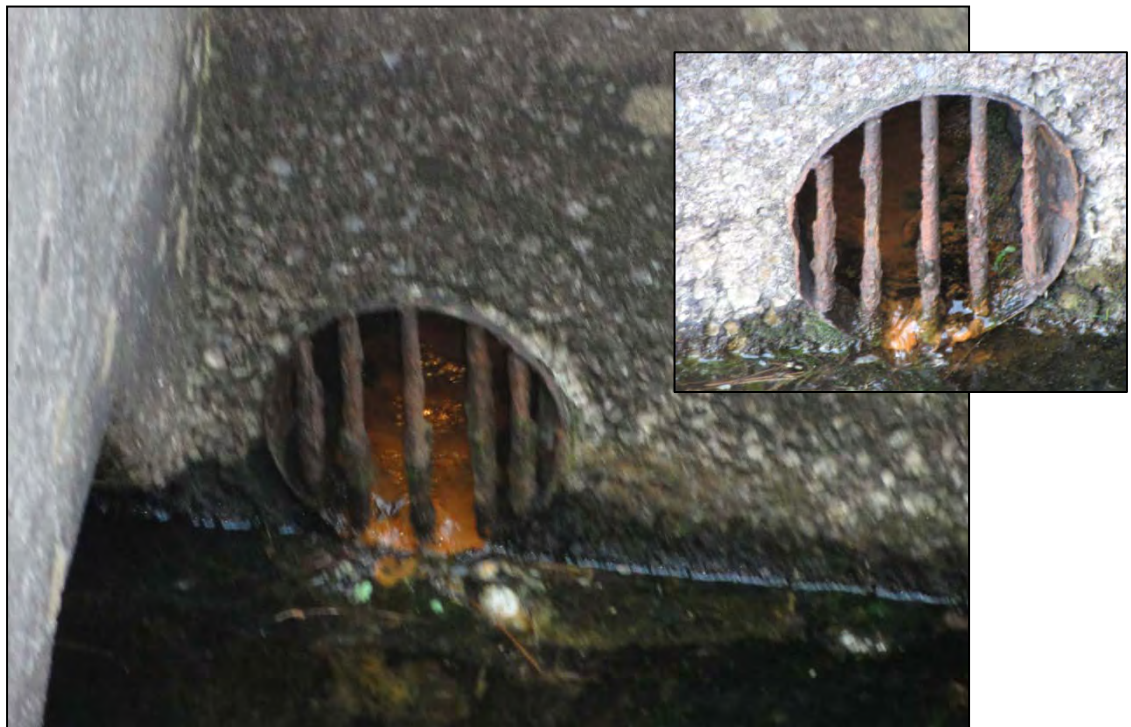
14. CMP drains.
