## Gragston Creek Project

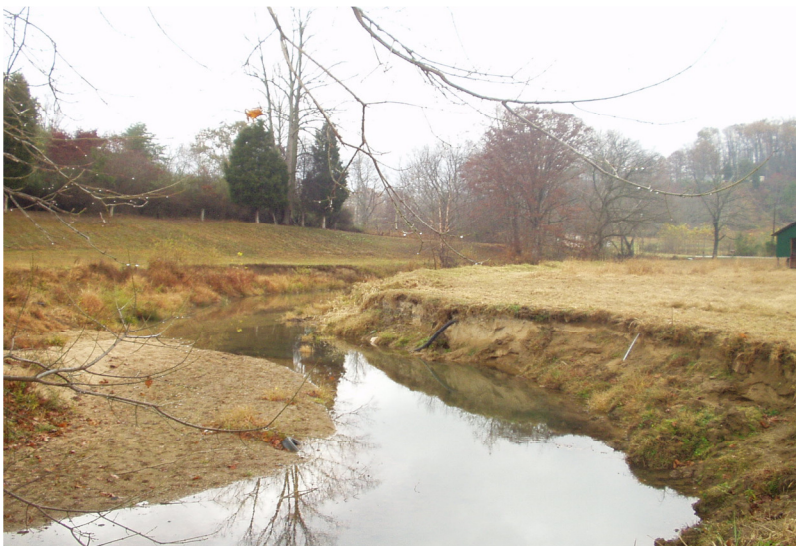
Over the years, the stream became an intimidating presence for this particular pasture. Riparian vegetation had been removed and the channel altered decades ago. The stream was slowly, methodically gobbling up ground at an outside bend in the stream.

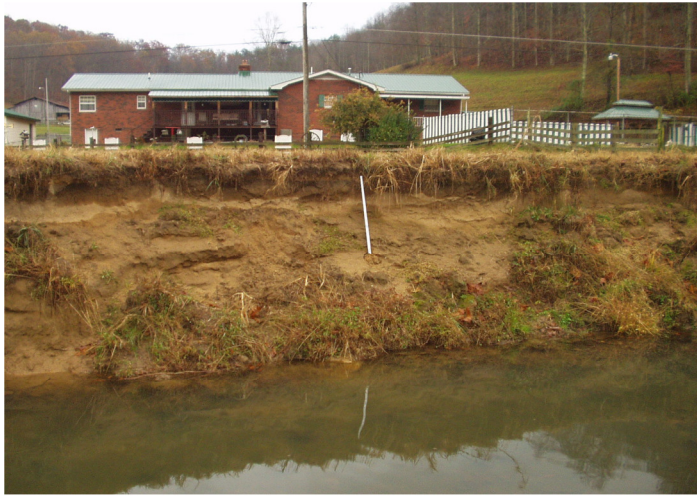
A Bank Erosion Hazard Index Evaluation (BEHI) was conducted in the fall of 2010 to establish load potential in preparation for a project proposal. Calculations estimated a load of approximately 41 tons of sediment per year and a potential lateral movement measured in feet.

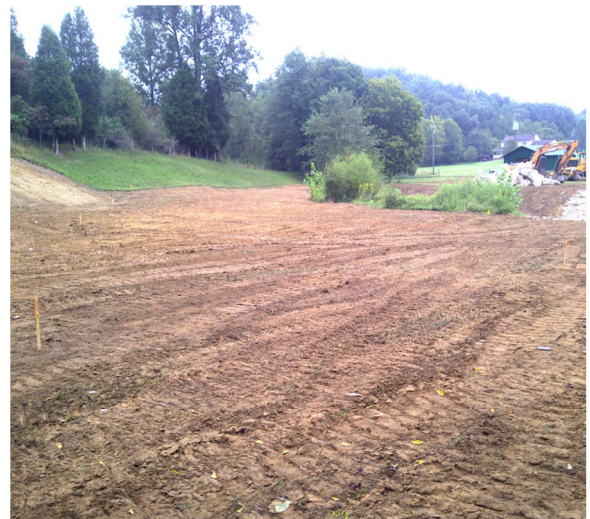
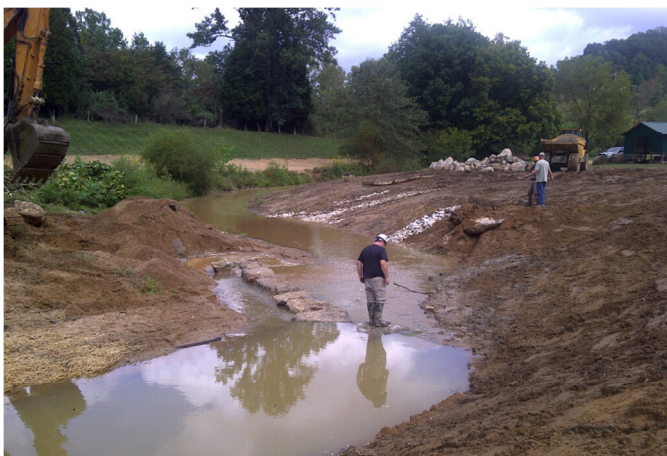
To stabilize the streambanks, natural stream design techniques were employed. Two combination rock/log structures were constructed to manage the flow of the stream. Additionally, nearly 2,800 cubic yards of material were removed from the opposite bank. The excavation would allow the stream to access floodplain resulting in reduced peak flows and more natural stream flow characteristics; ultimately reducing erosion potential at the project site.

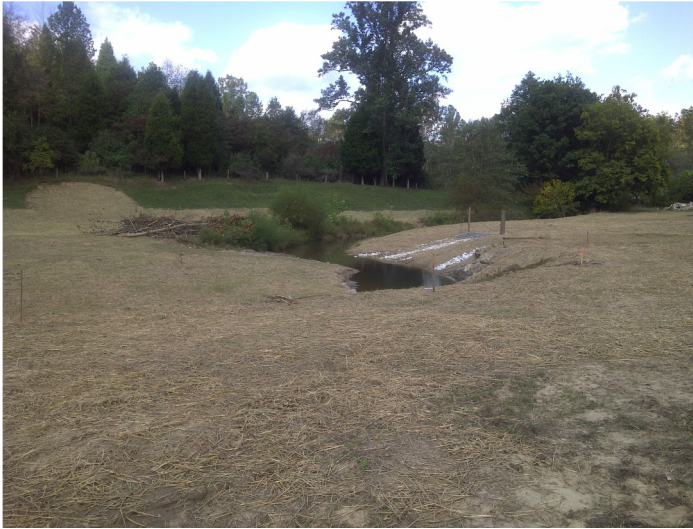
Establishing vegetation was and remains to be, a somewhat difficult step. A brush mattress was installed along the outside bend between the two in-stream structures. The project designer identified this portion of the project area as the most critical because of the energy that would be present during bankfull events. The brush mattress was constructed by driving 36 inch wooden stakes on a grid pattern at 4 foot centers. A mixture of black willow,

sycamore and silver maple cuttings were then secured with 12 gauge wire tied in a diamond pattern. In addition to the brush mattress, a combination of willow, red osier, and silky dogwood live stakes were planted along the riparian area. The site has endured multiple bankfull events since construction finished in the fall. Despite a large portion of the live stakes lost to high water and the development of some erosion along the tow of the critical area, the project has succeeded in stabilizing the streambank. These issues will be addressed by the Conservation Specialist and landowner during the summer months.

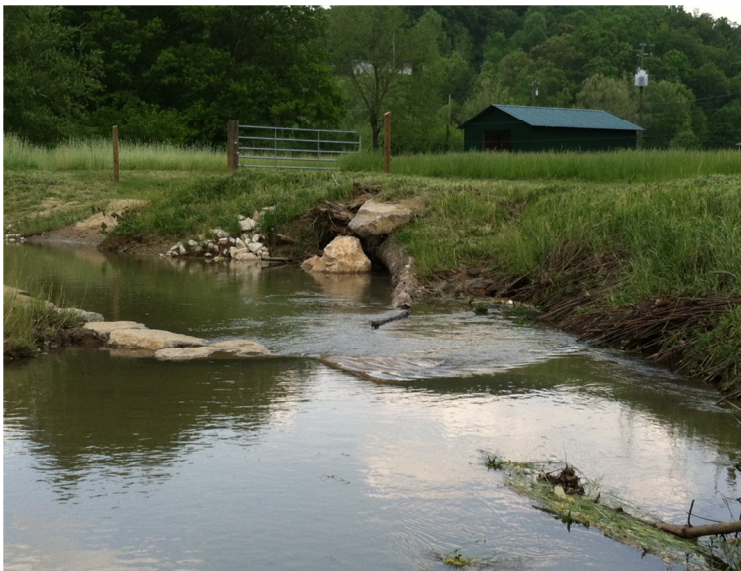
Projects of this nature are dynamic as the stream itself. Although construction ended several months ago, a small amount of tweaking was and is to be expected. Scouring and erosion along the log vane of the second structure will be addressed this summer as well as additional efforts for planting live stakes to replace those lost during the spring floods. In review, one can look at the entire project as a learning process for everyone involved. The project has achieved its purpose in stabilizing the failing streambank as well as reducing the sediment contributions. Additional benefits include the removal of livestock from this stretch of stream that will undoubtedly serve to reduce nutrient and fecal loading. Perhaps the biggest improvement is the change in attitude of the landowner who now advocates on behalf of the functionality and importance of riparian zones. Hopefully this is just the start...
