South Branch Watershed Association of Hampshire County Implements National Fish & Wildlife Grant

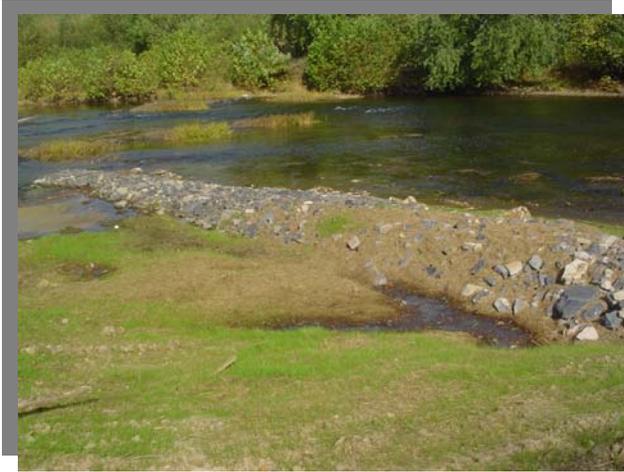
Herriott Natural Stream Restoration Site

A point bar forming on the right descending bank has narrowed the channel, increasing shear stress on the left descending bank causing erosion. In addition, the “growing” point bar has deepened the channel, reducing the usability of an existing ford, the only access to the property owned on the south west side of the river. The goal at this site was to reshape the point bar to encourage sediment transport through the system without encouraging deposition. The project was completed by removing the outer edge of the bar, creating a channel approximately 310 feet in width, similar to the widths measured both upstream and downstream for the site. The newly constructed outer edge of the point bar was sloped steeper than the existing slope, approximately 2:1 or slightly steeper. This allows helical currents at bankful flows to transport sediment through the reach without causing deposition. Material removed from the outer edge of the bar was used to construct the bench, forming an “inner berm”. All disturbed areas above bankful were re-shaped to a 2:1 slope or flatter. They were then reseeded. Woody vegetation will be established during the spring. Approximately 900 linear feet of stream bank was stabilized through this project.

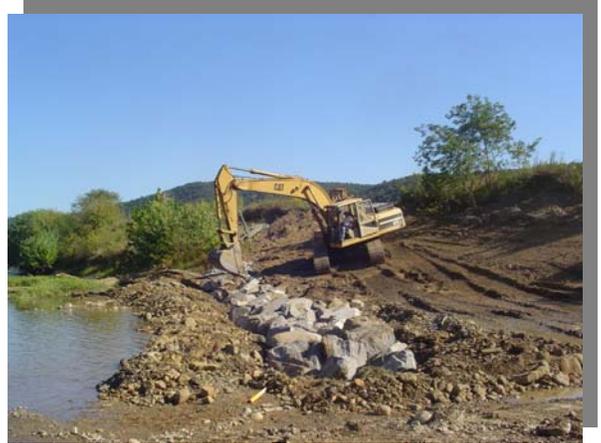
This site posed the challenge of severe erosion occurring on approximately 500 linear feet of stream bank. The site was adjacent to a pasture field. Vertical cuts were measured at 20 feet in some areas on the site. Portions of a small mid-channel bar were removed to help construct a bankful bench. Material was lacking to fully construct the bench, therefore two vanes were constructed to reduce near bank stress and encourage deposition in appropriate areas. These vanes were constructed by “dumping” 36 inch shot rock in the form of a rock vane. All

appropriate angles and slopes were adhered to and the rock was compacted into place. The idea behind building the structures in this manner was to reduce construction time and costs. Upon the end of construction, steeply eroding areas were reshaped to a 2:1 slope or flatter, reseeded, and a riparian buffer was established. Woody vegetation will be established in the Spring. Approximately 500 linear feet of stream bank was stabilized through this project.
