ELK CONSERVATION DISTRICT  
BIO ENGINEERING PROJECT

HAMRIC FARM  
VERNON AND DEBBIE HAMRIC  
TATE CREEK -- BRAXTON COUNTY

Bruce Skidmore Conservation Specialist WVCA

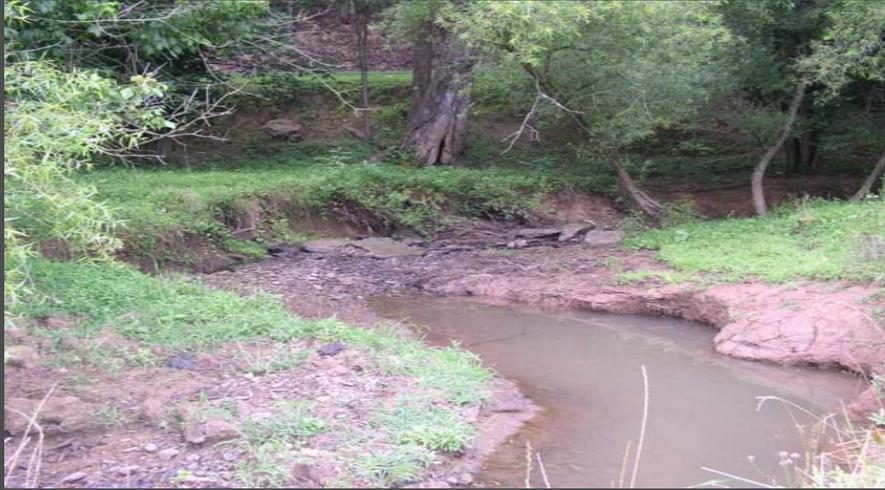
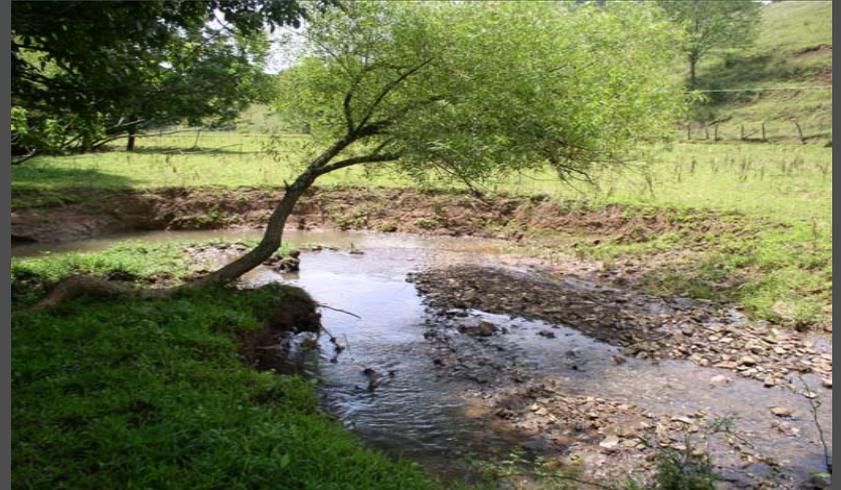
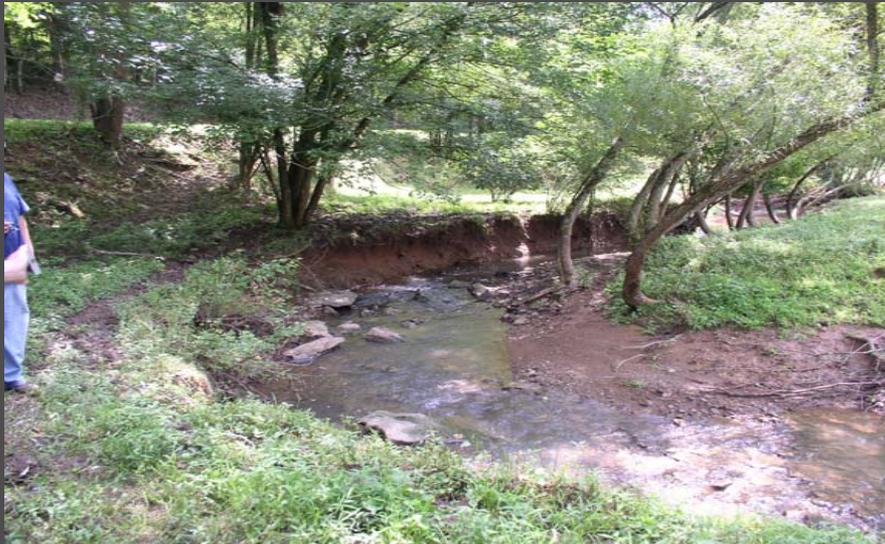
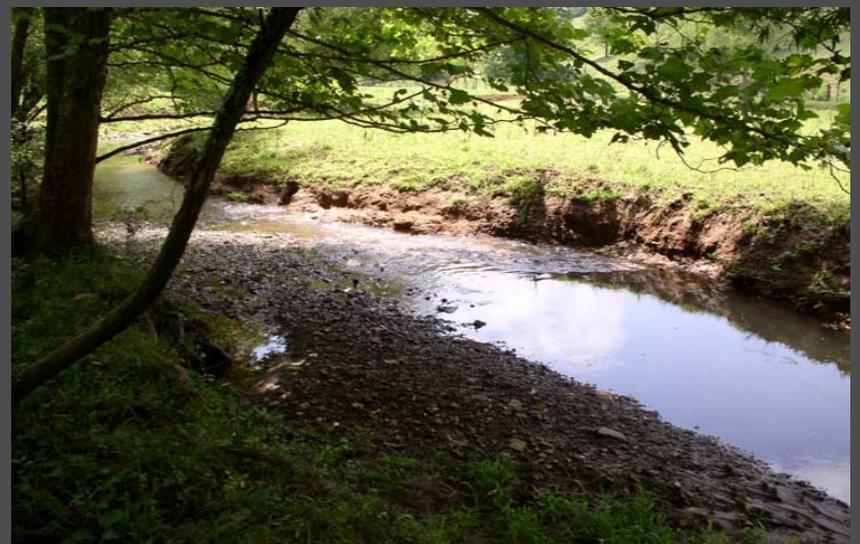
Mr. Hamric was loosing approximately 50 ton/ac/year of soil from his pasture

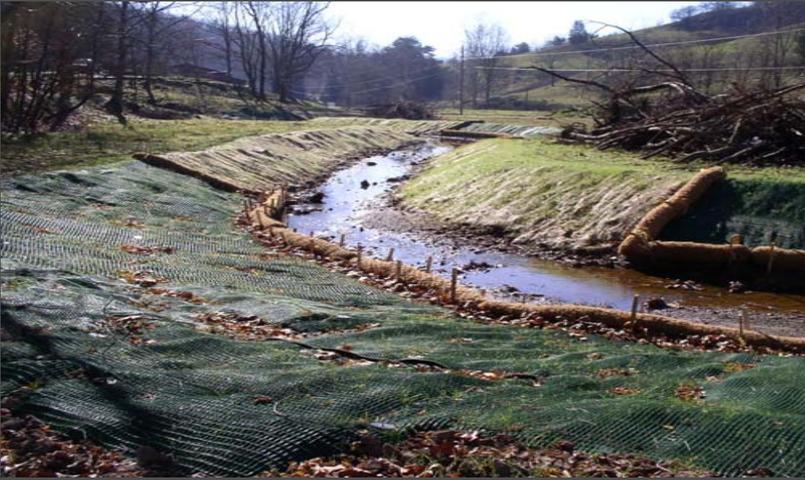
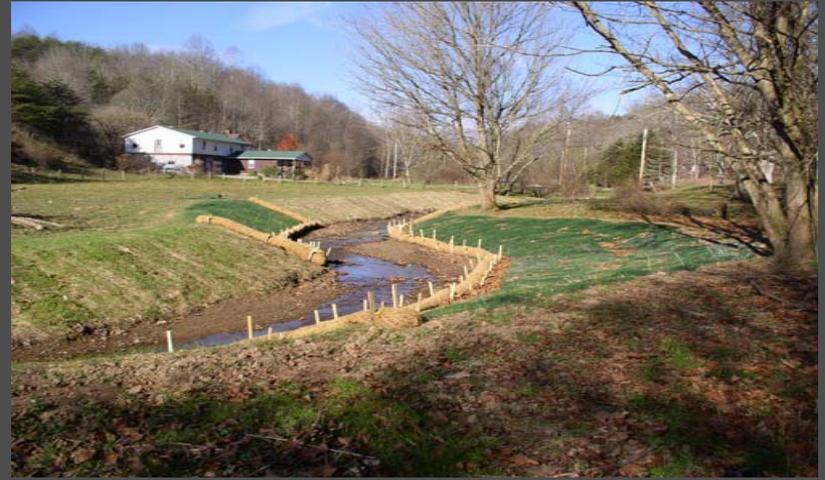
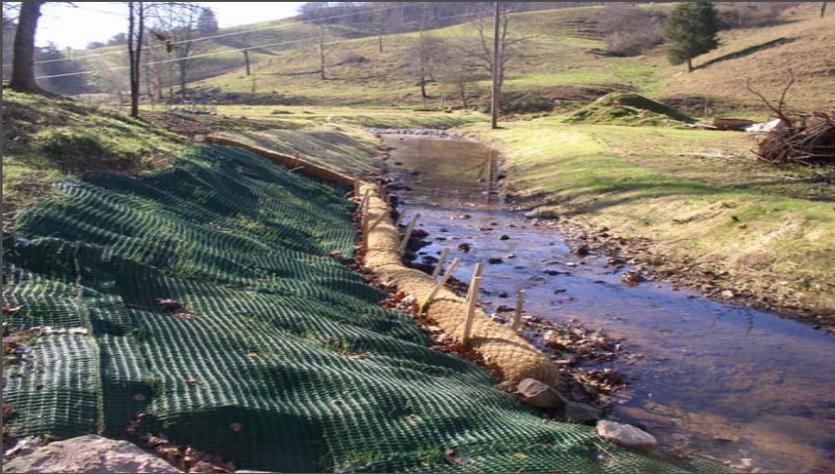
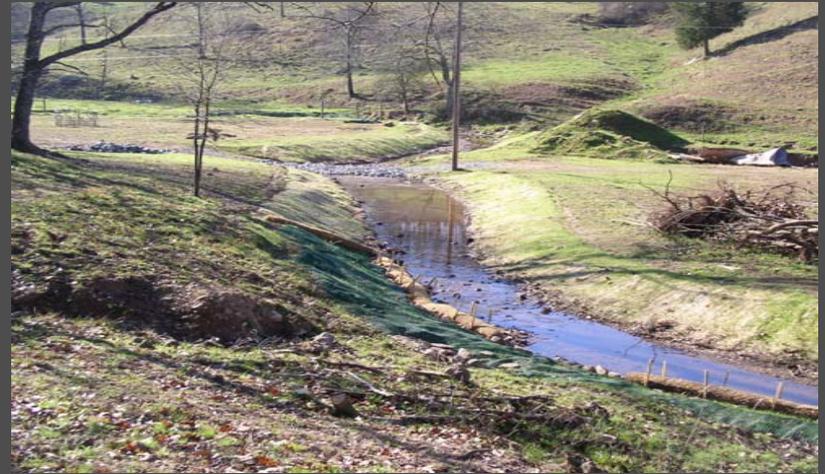
Different views of the project after completion

Approximately 1600 linear feet of stream bank was stabilized, roughly 12,800 square feet
