# REHABILITATION ASSESSMENT REPORT

## Brush Creek Watershed Site 9

Mercer County, West Virginia

**March 2011**

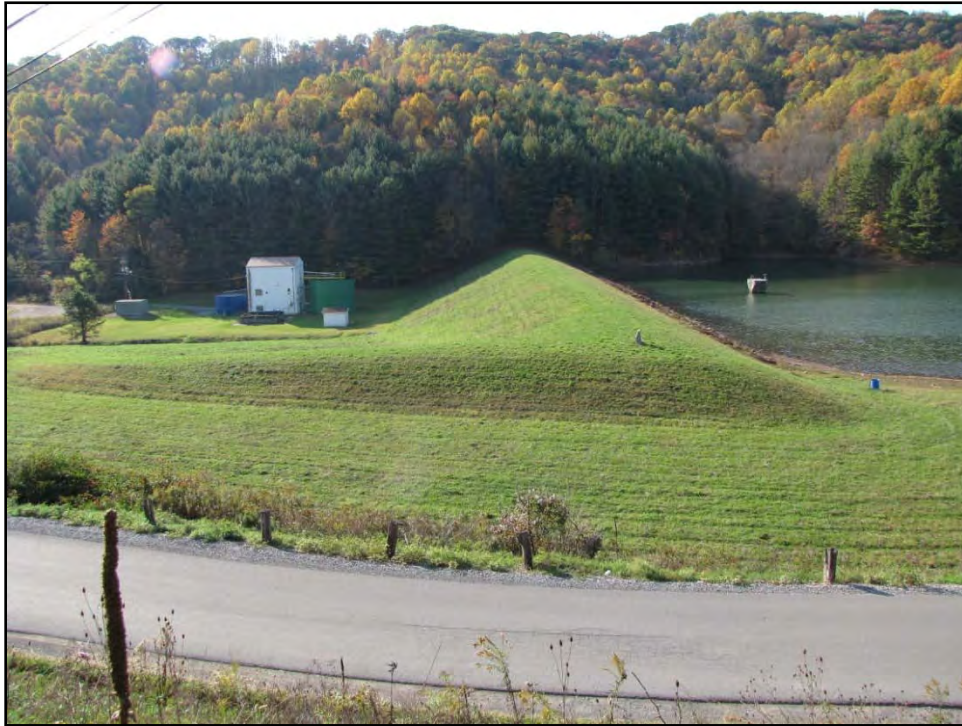
1. General overview of dam from left side of auxiliary spillway.

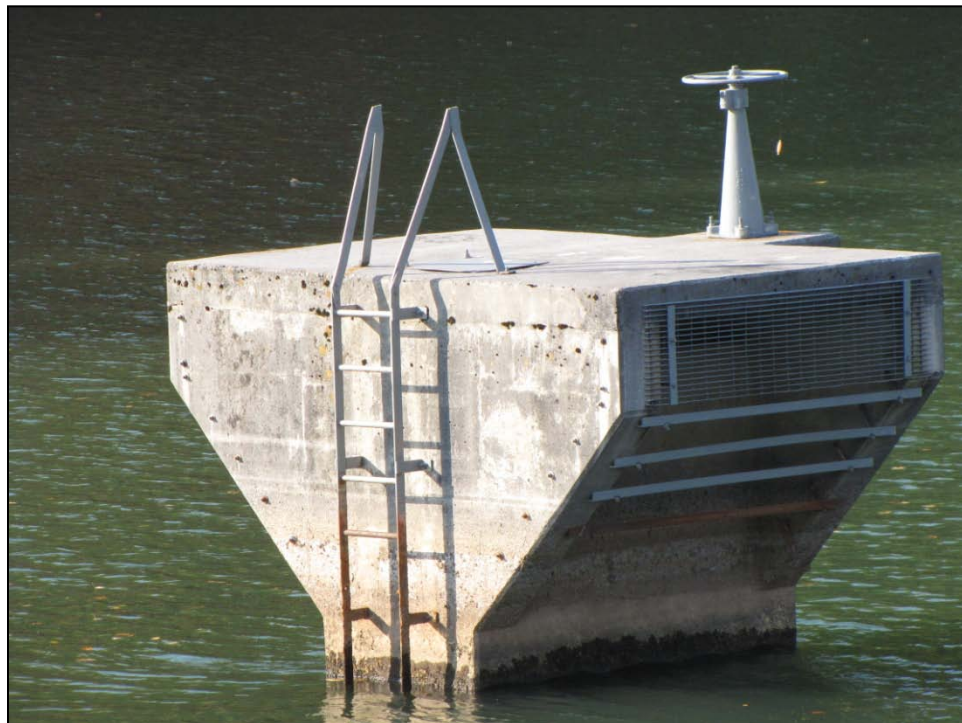
The concrete principal spillway riser structure and stilling basin appear to be in good condition and operating as designed. No external evidence of cracking or deterioration was observed. Metal parts on the lower portion of the riser are showing signs of corrosion and need to be painted. The bottom rungs of the ladder are missing. Sediment and vegetation are clogging the outlet channel downstream of the stilling basin causing a backwater that extends over the endsill and nearly submerges the conduit.

2. Principal spillway riser structure.

Items of deferred maintenance include repairing and armoring areas damaged by wave erosion, seeding bare areas, painting corroded metal on the riser structure, repairing the ladder, removal of obstructions within the auxiliary spillway, and clearing sediment and vegetation from the outlet channel. Wet areas on both sides of the stilling basin should also be monitored.

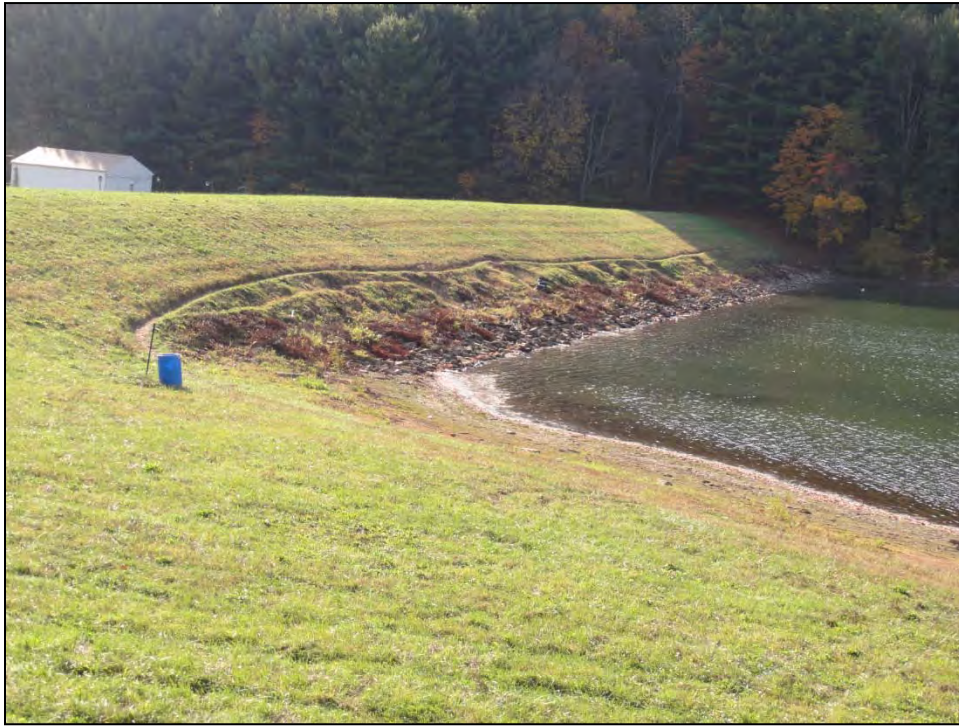
There are bare earth trails and areas of significant wave erosion and sloughing on the upstream slope of the embankment. The grass cover on the downstream slope of the dam embankment appears to be adequate.

3. Upstream embankment slope.

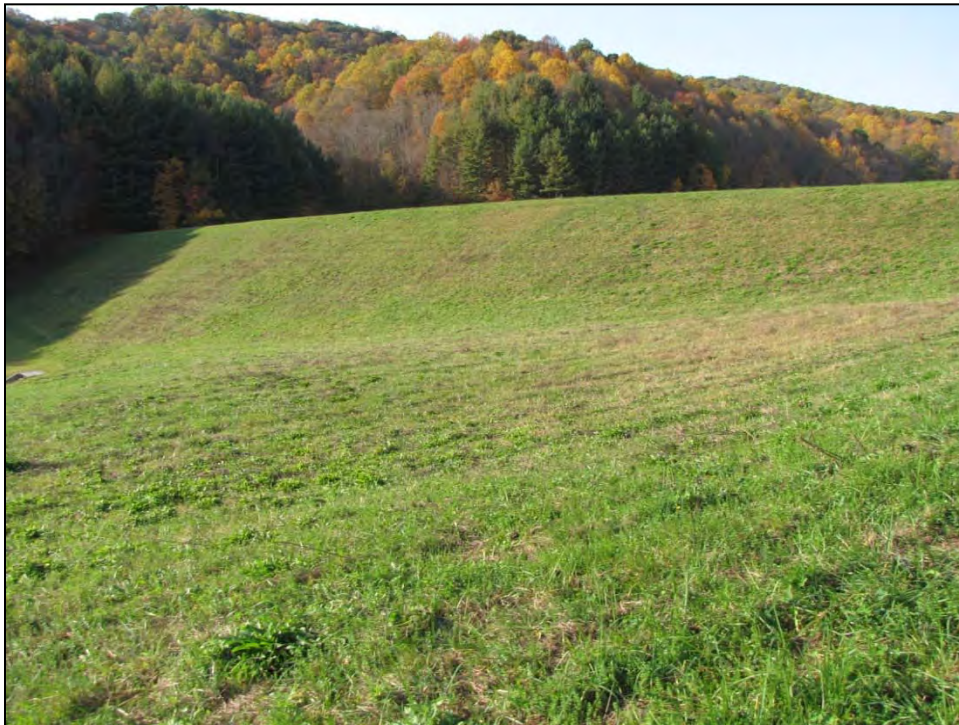
4. Downstream embankment slope.

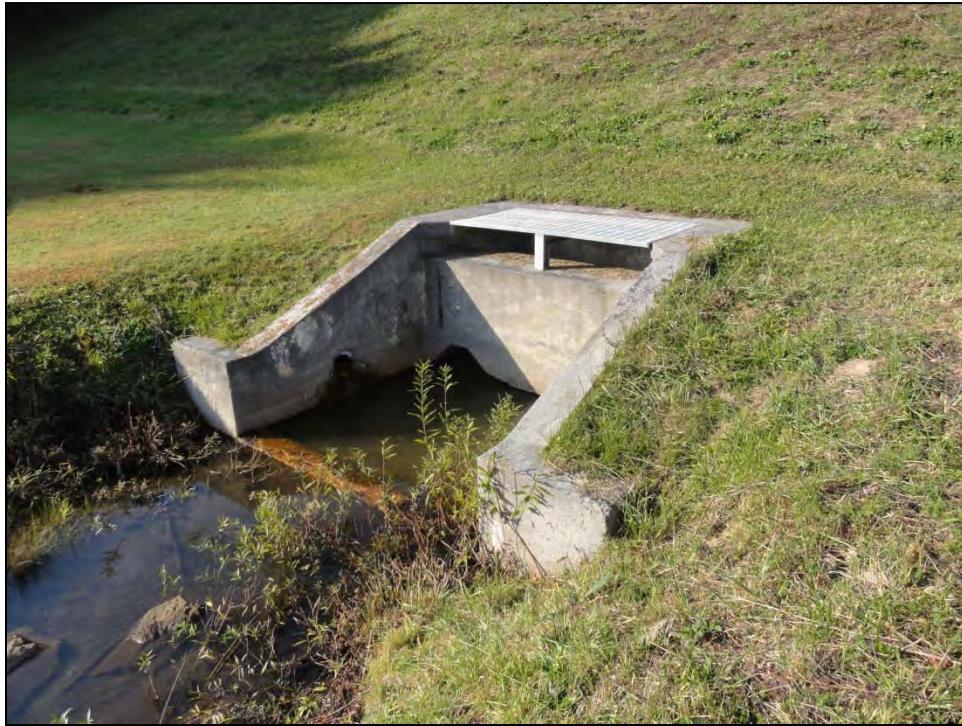
The CMP drains located on either side of the principal spillway outlet conduit were both flowing at greater than ½ gpm. Wet areas were observed below the toe of the dam on both the left and right sides of the stilling basin, possibly due to poor drainage. Otherwise, no signs of embankment instability or seepage were observed.

5. Stilling basin.

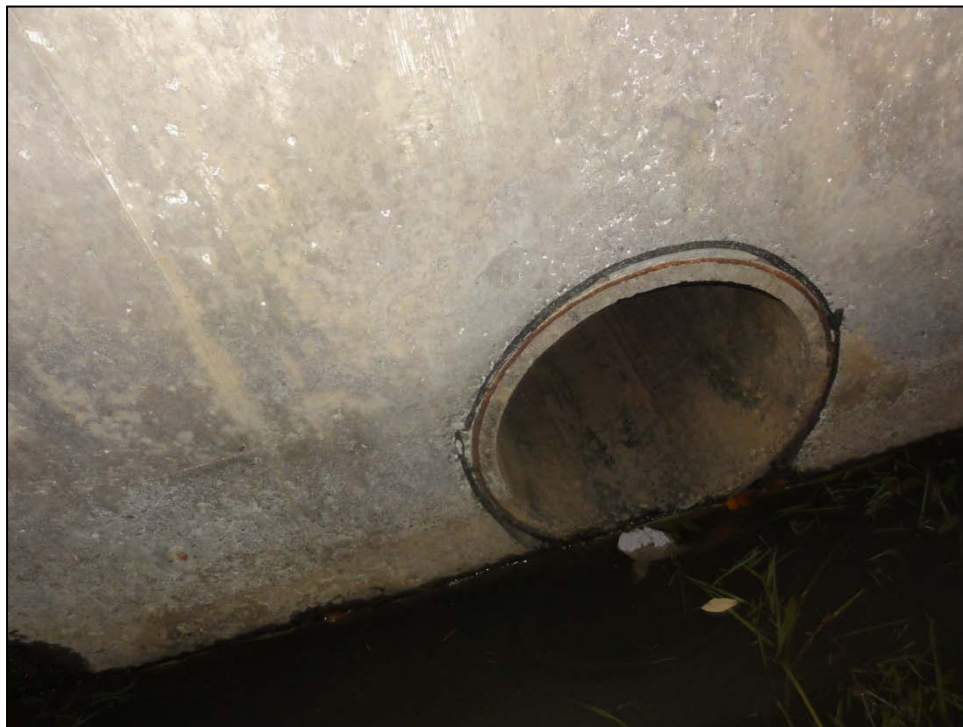
6. Outlet conduit.
