# REHABILITATION ASSESSMENT REPORT

## New Creek Watershed Site 17

Mineral County, West Virginia

**March 2011**

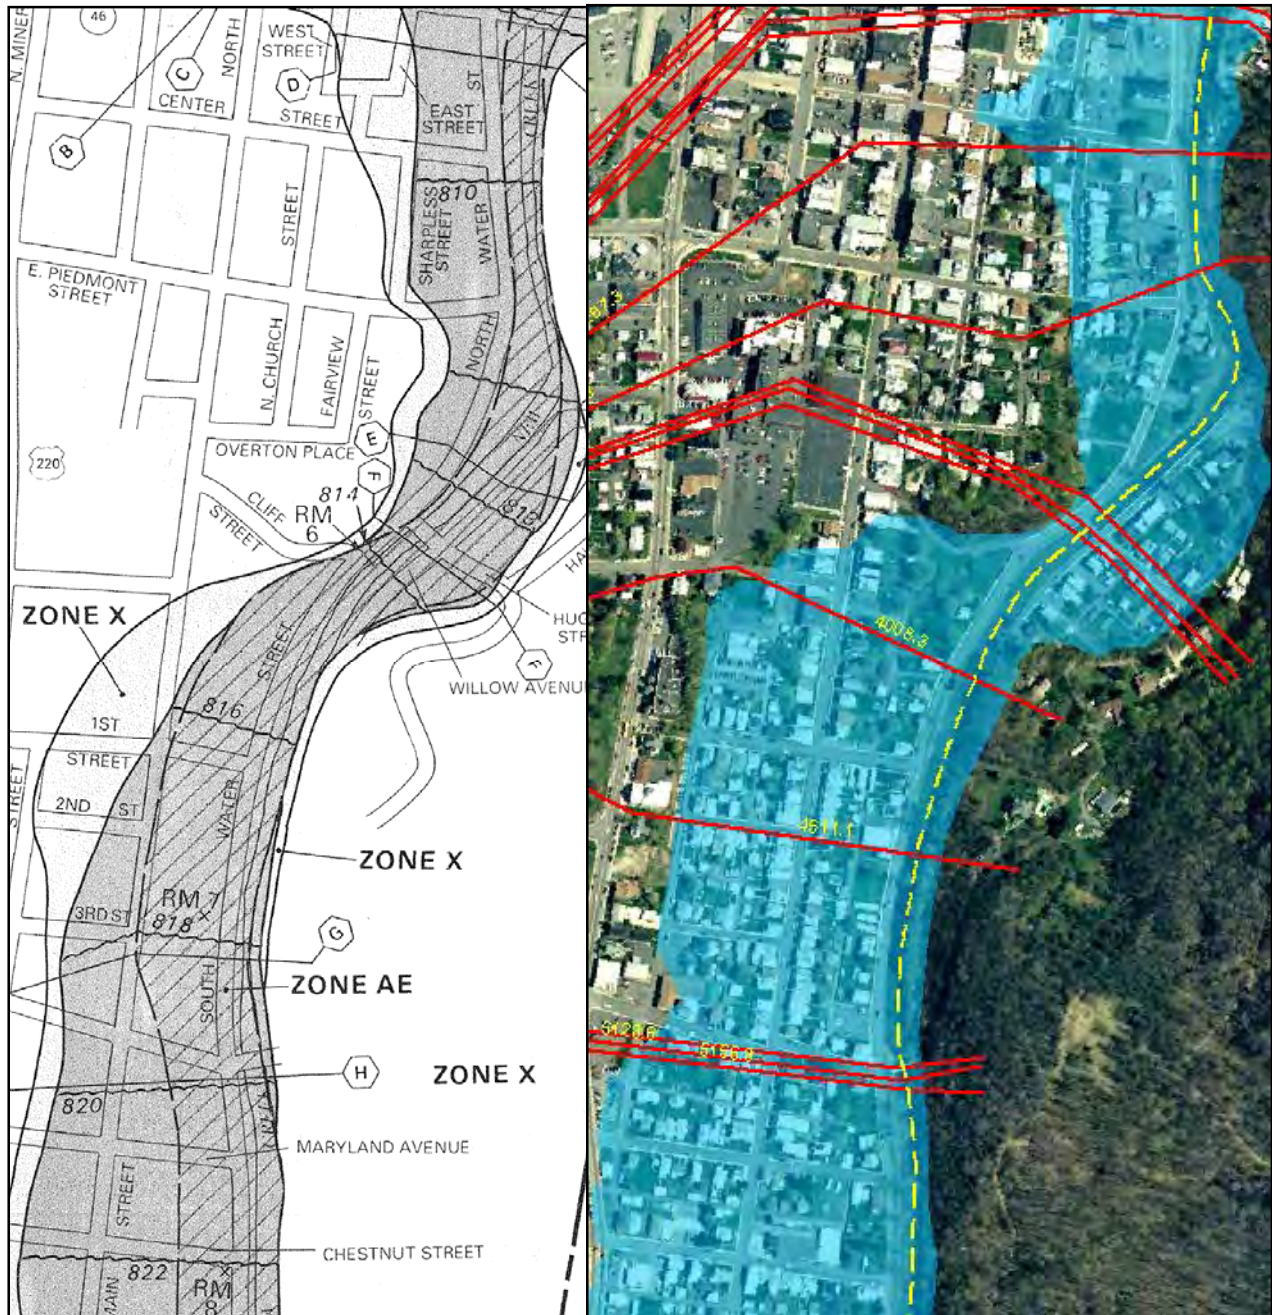
breach flow or flood wave at Keyser is approximately 14,800 cfs or 13 percent of the peak breach flow at the dam. The resulting inundation limits in the vicinity of Keyser were compared with the inundation limits shown on the existing detailed FEMA Flood Insurance maps for the same area for the 100-year and 500-year flood events. At Keyser, the peak 100-year and 500-year FEMA flood flows were estimated to be 10,610 cfs and 15,710 cfs, respectively. The peak FEMA 100- and 500-year flood elevation near the center of Keyser were reported to be 809.5 feet and 813 feet. The peak dam breach flood elevation at the same location was computed to be 807.5 feet. A side by side comparison of the dam breach inundation mapping and the FEMA Flood Insurance mapping at Keyser is presented in Figure 4.

Figure 4. Side by Side Comparison of Floodplain Boundaries from the 1991 FEMA Flood Insurance Study (left) and the 2011 Gannett Fleming Dam Breach Study (right) at Keyser, West Virginia.

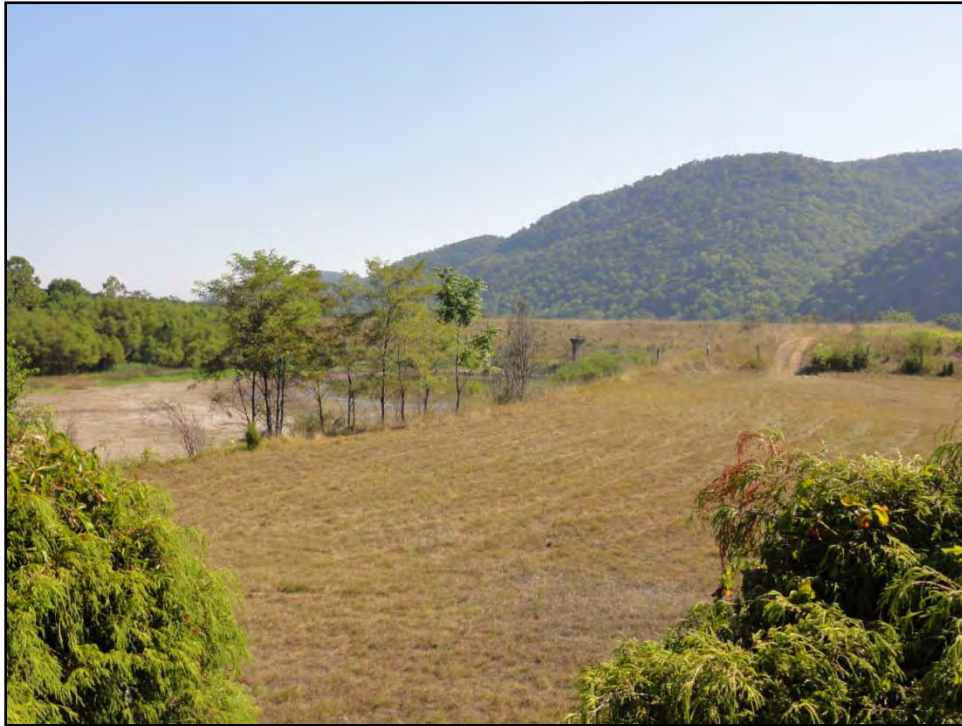
1. General overview of dam from right side of auxiliary spillway.

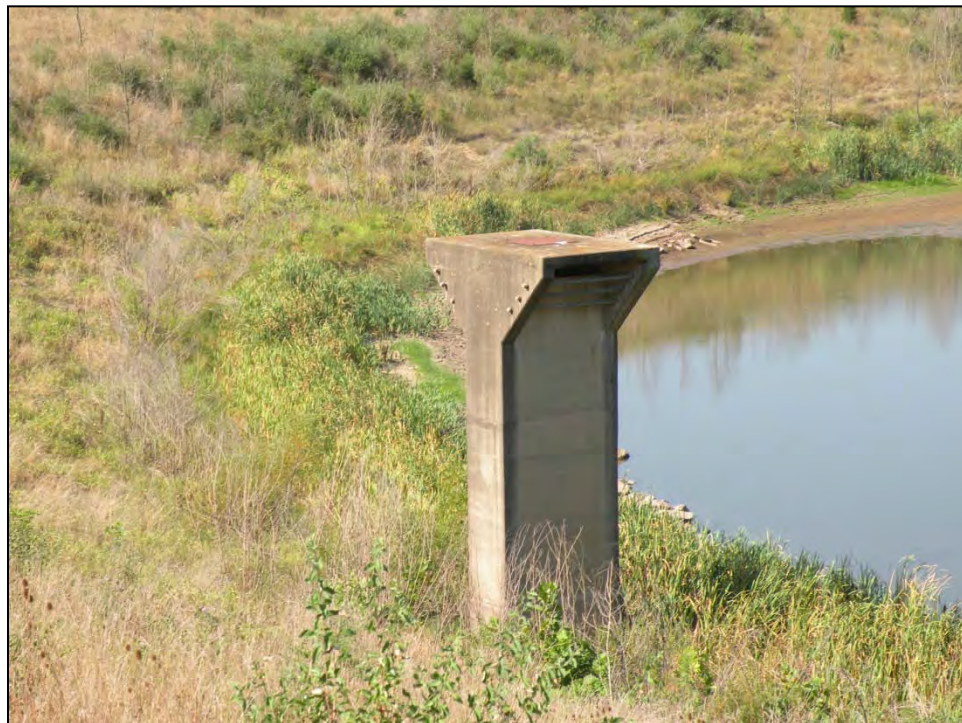
The concrete principal spillway riser structure appears to be in good condition and operating as designed. No external evidence of cracking or deterioration of the concrete was observed. The lower level trash rack and drawdown handwheel show signs of corrosion and need to be painted. There is also some minor debris on the lower inlet trash rack as well as a large tree branch lodged in the principal spillway riser structure.

2. Principal spillway riser structure.

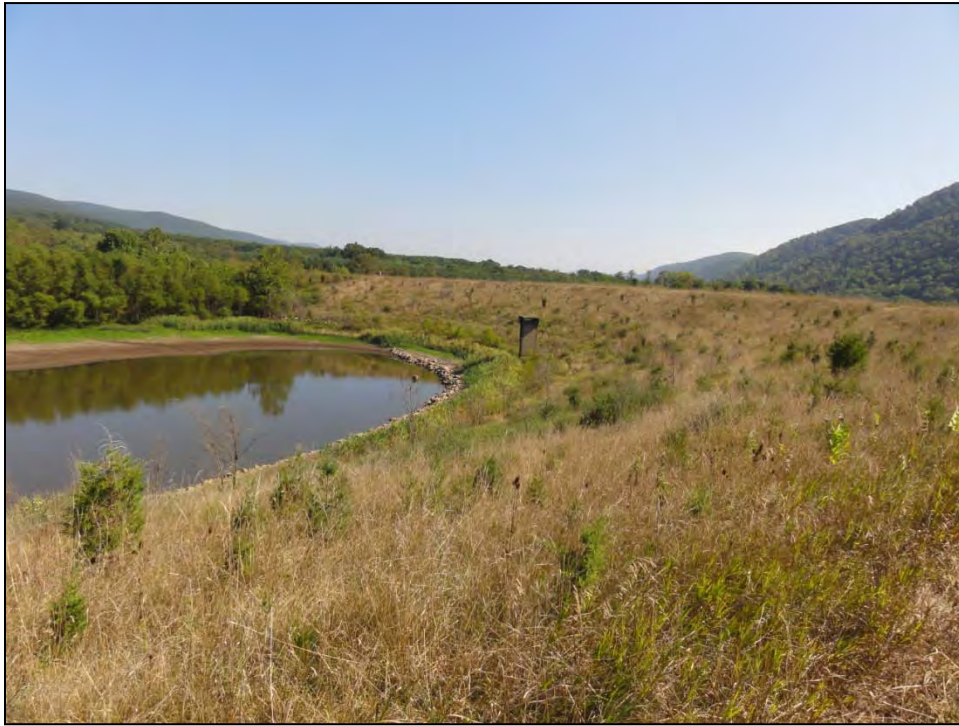
The grass cover on the upstream and downstream slope of the dam embankment has not been mowed for several years as evidenced by brush and small trees on both the upstream and downstream slopes. The downstream slope was constructed with a steep 2:1 slope and armored in some areas with large cobbles. Due to the inability to mow the areas covered in cobbles, vegetation has become very dense in these areas. Additionally, the slope in these areas seems very irregular which suggests there has been some creep of the downstream slope. Large trees were also observed to be encroaching on the abutment contacts of the dam.

3. Upstream embankment slope.

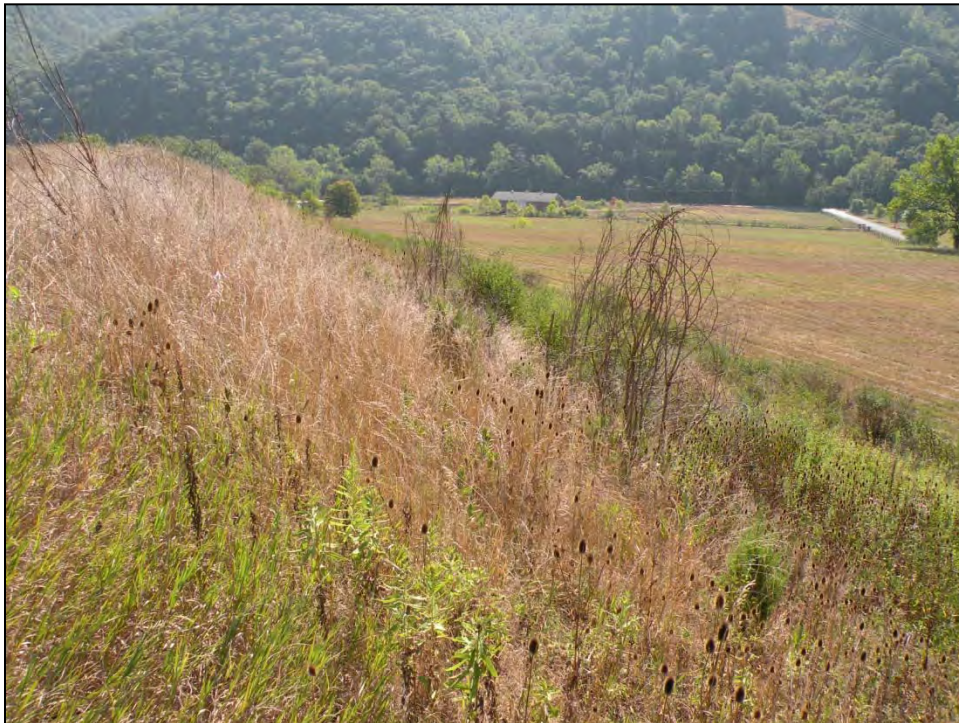
4. Downstream embankment slope.

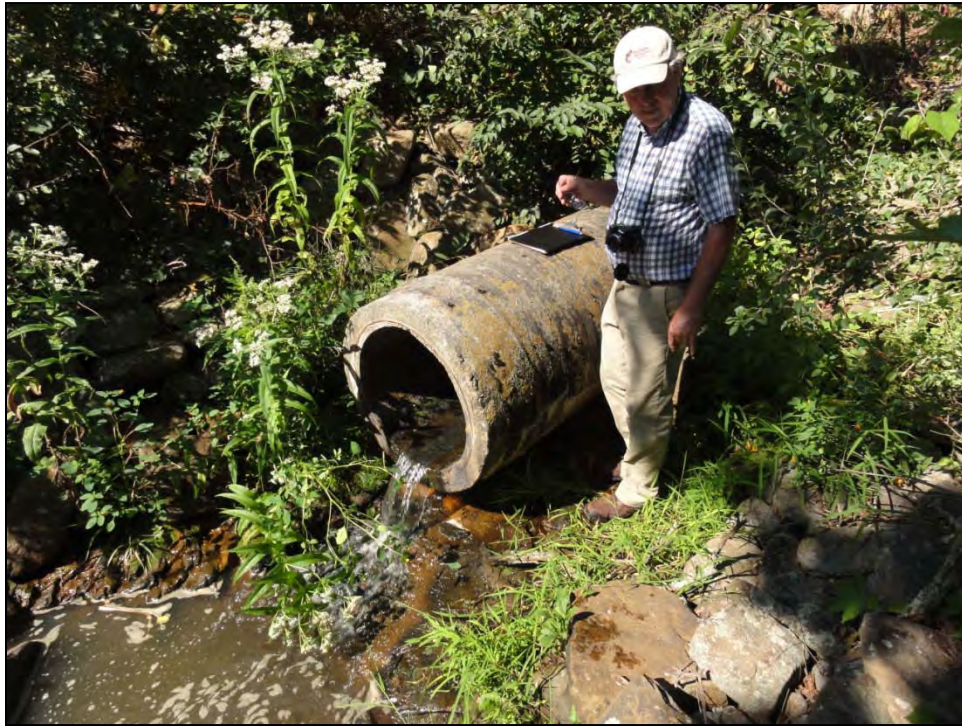
The principal spillway conduit outlet shows signs of significant deterioration including a fracture about 4 feet long. The outlet and plunge pool are surrounded and obstructed by thick, woody vegetation. A seep was observed beneath the cradle of the principal spillway outlet conduit. The seep was visibly flowing. No drains were observed at the site.

5. Outlet conduit.

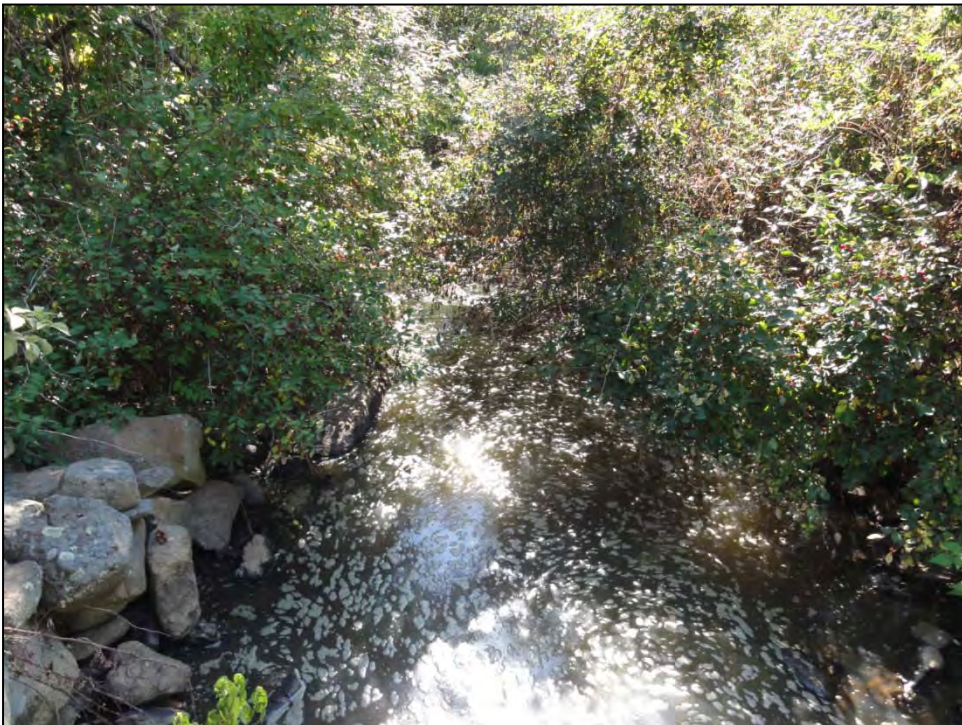
6. Plunge pool.
