WEST VIRGINIA CONSERVATION AGENCY 2009 STATEWIDE NPS PROGRAM NPS CATEGORY OF AGRICULTURE AND CONSTRUCTION October 1, 2008 – September 30, 2009

Pollutants: All; administrative, planning and project development for agriculture and construction

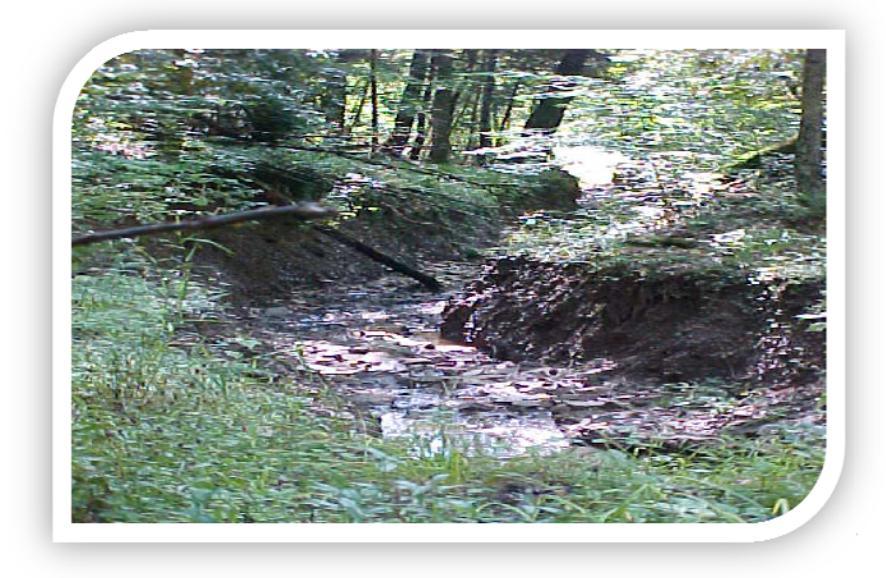
THIS WAS ONCE UPON A TIME A ROAD

The original stream bed remained intact with the exception of approximately 250 feet which had been destroyed by a combination of the logger's activity and off-road vehicle use. This stream reach would need to be recreated, the juncture of the road where the stream "blew out" blocked to divert the flow back into the original course and the disturbed areas stabilized.

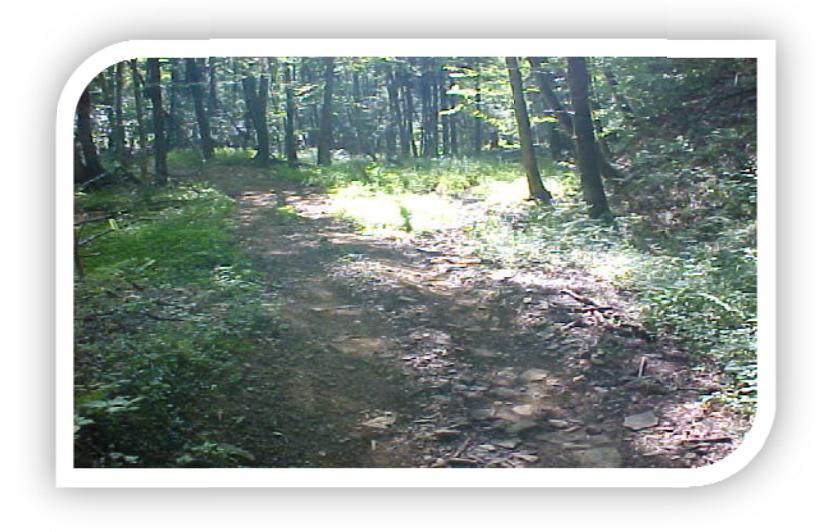
Measurements were taken within the gulley and calculations made to determine the amount of material that had been eroded were made and the banks were pinned in several places to be measured again later to determine the extent of erosion within that time frame. The pinning was done on November 9, 2007 and comparative measurements taken again on August 25, 2008 and approximately 274 tons of additional earth and rock had eroded from the banks of the gulley during that period.

THIS WAS ONCE UPON A TIME A STREAM

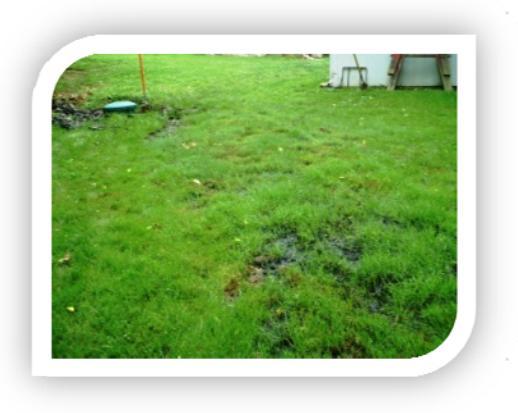
FAILING SEPTIC SYSTEM

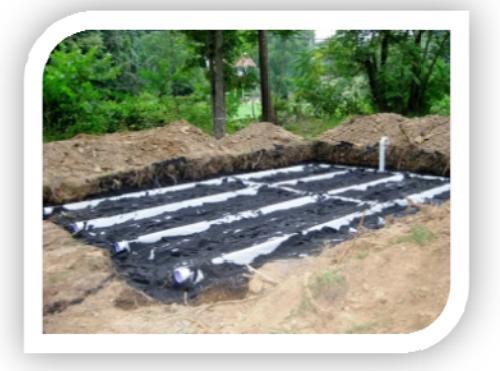
INSTALLATION OF AN ELJEN BED

The Sleepy Creek Incremental Project proposal's budget is \$487,586.00, which is 60% 319 funds of \$292,550.00 and 40% of local and state match of \$195,036.00. The goal of the Sleepy Creek 319 Incremental Project is to reduce the fecal coliform loads within the watershed. One of the teams' goals was to repair 25 septic systems; they have completed over half of this goal with 6 more to be installed by the end of October 2009. This summer the project team with help from the Morgan County Health Department has seen 14 different systems designed, completed and paid in the amount of \$90,055.00. During the same time the project team has paid \$1,137.50.00 for septic system pumping. This program has been very successful and shown a great need within the watershed. The Morgan County Health Department has already started to develop a waiting list for failing septic systems for future grant possibilities. The project manager has been invited to the Kearneysville District In-Service Meeting on October 30, 2009. The role of this meeting is to explain the process of how Sleepy Creek got the funding and the important role the health department had in making this program such a success. The goal is educate the local health departments to take part in their local watershed associations.

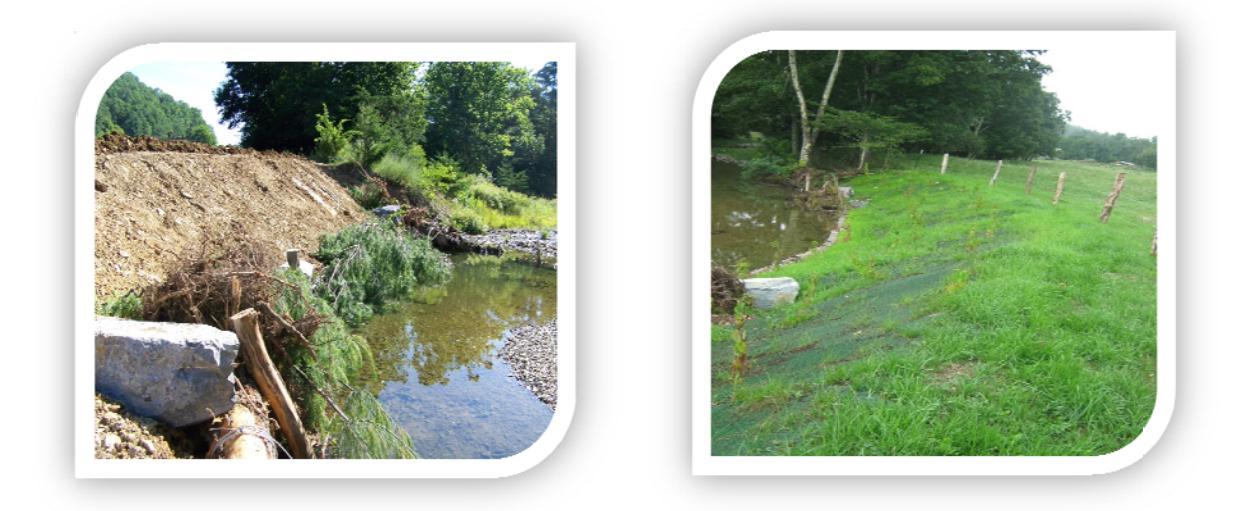
Soil Bioengineering Projects Greenbrier Valley Conservation District Site 1 on Anthony Creek

The first site is located on the Greenbrier and Pocahontas county line. At this site Anthony Creek was eroding an area of pasture land at a rate of 30.6 tons of soil per year according to the Revised Universal Soil Loss Equation. The soil on this site is a Potomac very gravelly fine sandy loam with a tolerable (T) soil loss rate of 3 tons per acre/year and an erodibility factor (K) of .24. During construction, the stream-bank was sloped to a 2:1 grade, removing 50.31 tons (37.30 cubic yards) of unstable soil from the streambank. This soil was placed in an upland location and stabilized from future erosion.

Tree revetments are non-sprouting trees installed along the toe of streambanks. The purpose of a revetment is to slow stream velocity adjacent to an eroding bank and to promote sediment deposition at the toe of the bank. The revetment material does not need to sprout. It is generally recommended that live willows or other quickly sprouting species be planted behind the revetment to provide permanent cover.

The site is 170 feet long and was stabilized using a high performance turf reinforcement mat (TRM) and earth anchor system, commercially known as the Armor-Max system. A tree revetment utilizing on site materials and rock from a local quarry was used to stabilize the toe of the bank and anchor the TRM. In recent years technology has been developed utilizing geosynthetic materials and earth anchors to stabilize failing and newly graded slopes. This is known as anchored reinforced vegetation systems. Generally these materials consist of uniquely shaped polypropylene fiber yarn woven into a turf reinforcement mat. The unique shape allows the matrix to capture and retain moisture, soil, and seed. This system installed with earth anchors has a field tested pull out capacity of 500 lbs with a

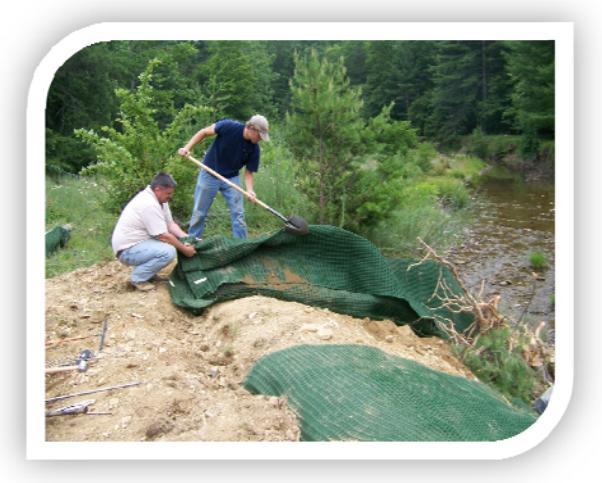
Note: The installation practice in the photo is the trenching of the edge of the mat in a manner that it can be flipped back overtop of itself to prevent high water from undercutting.

HPTRM should be installed in a shingling manor starting on the down stream end of the site working up to prevent water from working underneath. Anchors should be placed in a diamond pattern over the mats and straight along the edge of the mats. If tree revetments are not used, the bottom needs to be anchored with rock. The anchor forms a cone of pressure creating approximately 500 lbs of pull out pressure. The finished system will provide the same effect as rip rap with more vegetation established quicker.

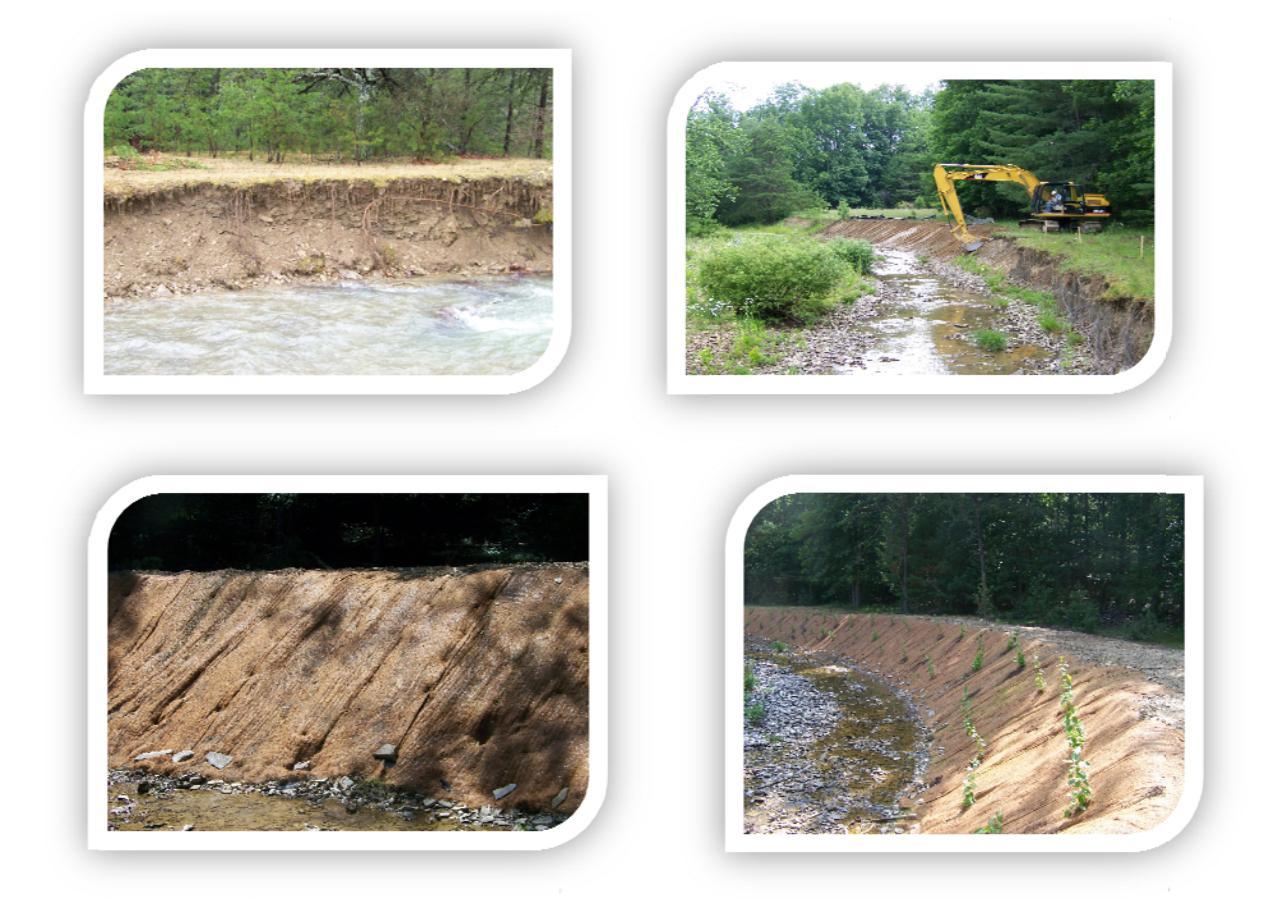
Site 2 on Anthony Creek - Utilized Coconut Fiber and Tree Establishment Banks were sloped to a 2:1 slope

The second site developed on Anthony Creek utilized less hard armor due to the lower stress on the bank. Coconut matting was installed to prevent sheet erosion on the banks while grass was establishing. Site 3 on Anthony Creek - Utilized Root Wads (the most traditional soil bioengineering practice utilized in this project)

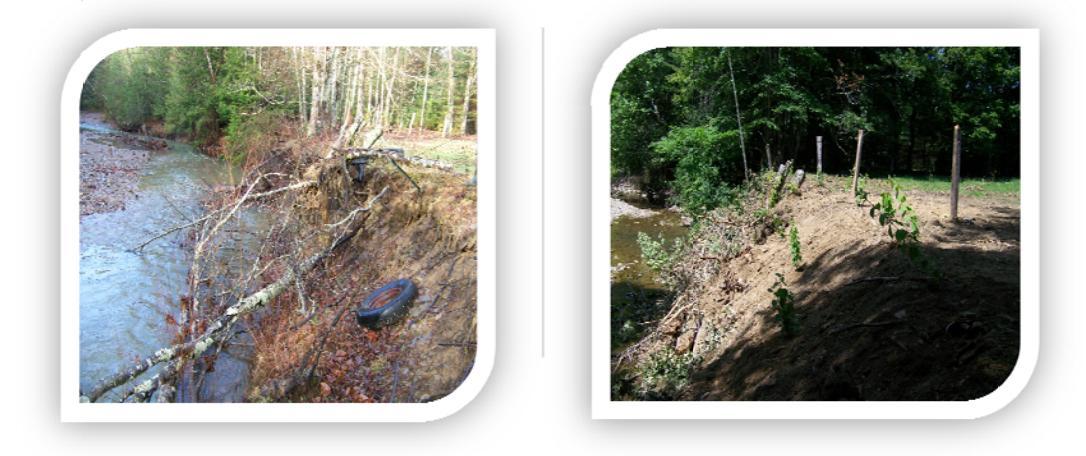
Root wads armor a bank by keeping the current off the bank. They should be used in combination with other soil bioengineering techniques to stabilize a bank. Three trees were used. The tops of the trees were used as footers and the lower parts were driven into the bank with the root wads exposed. Soil was backfilled and trees were planted to develop an additional root system.

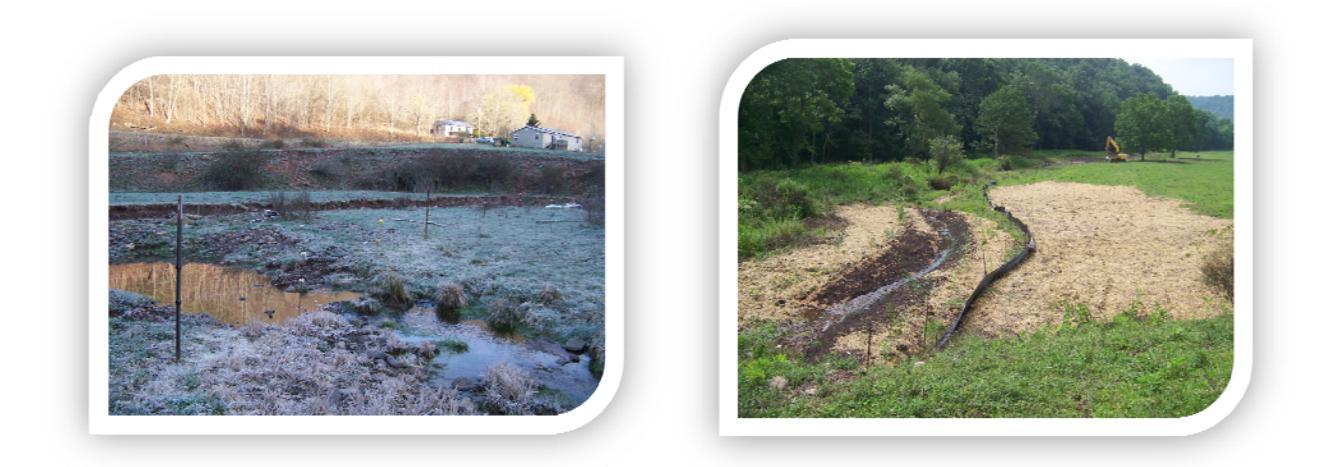
Kitchen Creek Soil Bioengineering Project (Greenbrier County)

A braded channel in Kitchen Creek is eroding away pasture land. A new channel was established, ARVS was established on the outside bank to prevent it from washing out into the pasture, coconut matting was used on the inside bend of the new channel. Trees were also established to develop the "firewall" root system. A compost blanket was also used to encourage rapid herbaceous growth.

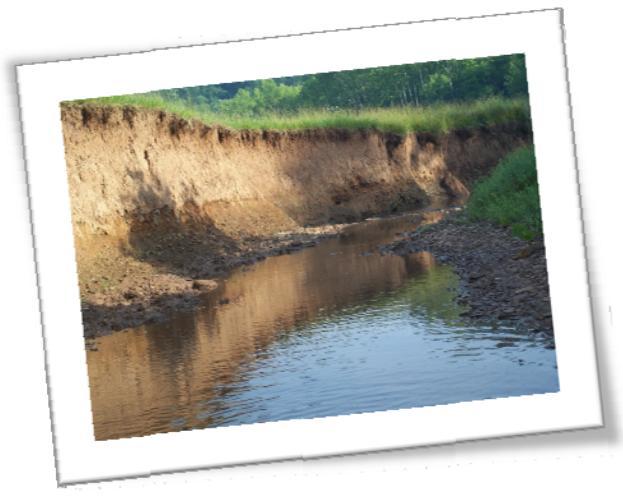
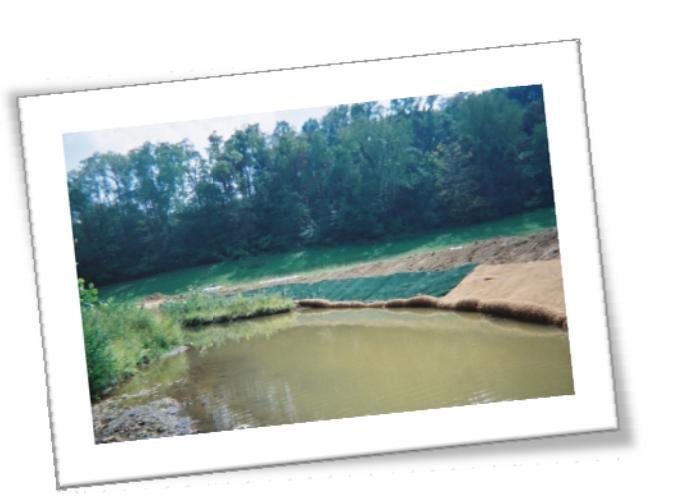
Stream Bank Erosion Monitoring On Cow Creek Leads to Soil Bioengineering Project

In Pleasants County, Cow Creek was eroding an area of pasture land at a rate of 41 tons of soil per year according to the Revised Universal Soil Loss Equation (RUSLE). The soil on this site is a Gilpin-Upshur complex with a tolerable (T) soil loss rate of 3 tons per acre/year and an erodibility factor (K) of .32. On this site, the streambank was sloped to a 3:1 grade removing unstable soil from the streambank. 462 tons of soil was placed back into the bends of the stream to re-establish the original pattern of the channel. The total site length is 300 feet long and was stabilized using two types of erosion control devices.

A high performance turf reinforcement mat (TRM) and earth anchor system, commercially known as the Armor-Max system was used in the 90 foot section of the bank that receives the most stress from high water. The remaining 210 feet were covered with a straw rolled erosion control blanket. Coconut fiber logs were installed at the toe of the slopes to anchor the bottom of the mats and to prevent undercutting of the system. Grass was then seeded to establish permanent cover.

The total site covered 630 square feet and cost \$4,552.35. This cost broken down equals \$7.22 per square foot or \$64.98 per square yard. Utilizing the Revised Universal Soil Loss Equation (RUSLE), the new soil loss rate after the installation of these practices is .71 tons per year (98.47% difference than before initialization).

To achieve the same soil loss results for this project utilizing Rip Rap, the total cost of the project would have been \$6,144.65. Utilizing 51.97 tons of rock and twice as much labor, this would have cost \$9.75 per square foot.
